Forensic Evaluation and Testing of Existing Site Conditions Related to a Personal Injury Claim

During the construction of an order fulfillment center located in Colorado, a jobsite worker claimed he was injured when he touched a handrail installed at a staircase shortly after the pipe welding operation was complete. In addition to a burn to the hand, the worker also alleged injuries to his back due to jerking quickly to withdraw his hand from the rail and twisting his body in a manner that aggravated his lower back. After the incident, the claimant filed a lawsuit alleging negligence for the welder's failure to adequately demarcate and restrict access to the hot work area. A forensic engineering company was hired to re-create and analyze the site conditions, review the information provided, and determine to a reasonable degree of engineering probability the validity of the claimant's allegations in relation to the potential for temperature ranges likely at the time of the accident.

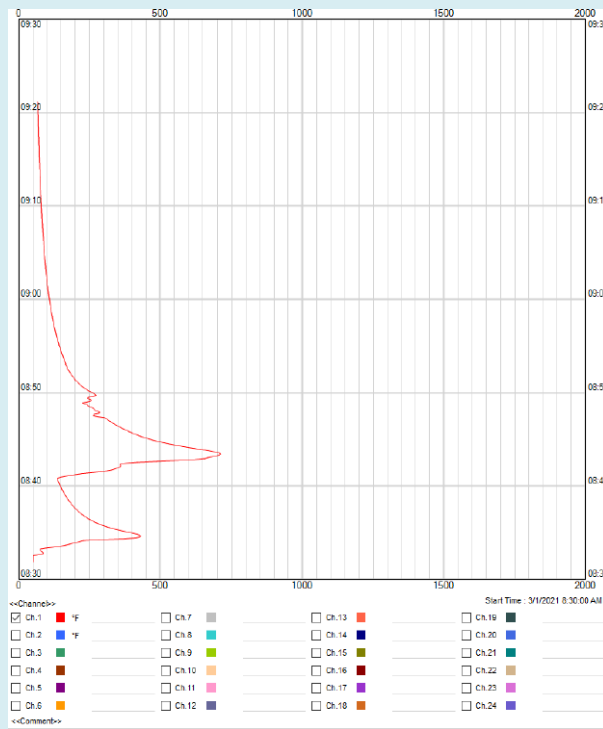
allow the welding equipment to reach 88-amperes, and then the welds were created again starting at the top and then moving to the bottom. A representative from an independent testing company measured the temperature using a thermocouple set near the weld location and provided a certificate of calibration of the equipment (Table 1) as well as a handrail weld temperature monitoring chart (Figure 2) [1] to the Engineer.

Figure 1: Handrail Weld Temperature Monitoring Chart. Time is Shown on the Vertical Axis and Temperature in Fahrenheit Is Shown on the Horizontal Axis.

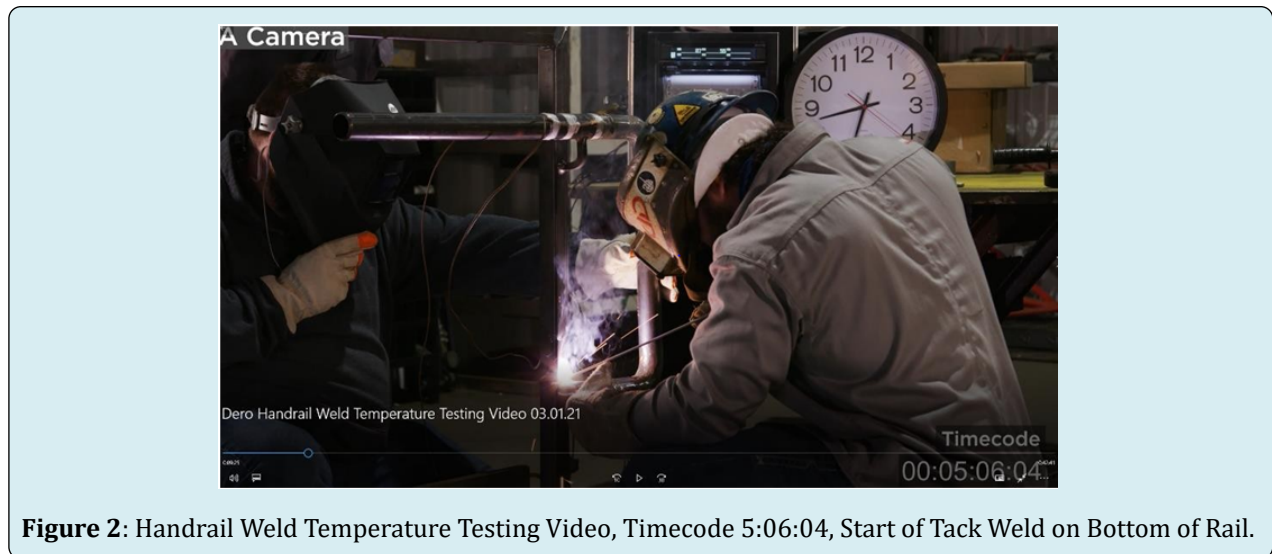
At the start of the tack weld, the ambient temperature in the room was 83-degrees Fahrenheit and the surface

temperature of the metal rail was 51-degrees Fahrenheit. See (Figures 2-9) for video stills showing testing details.

Figure 2: Handrail Weld Temperature Testing Video, Timecode 5:06:04, Start of Tack Weld on Bottom of Rail.

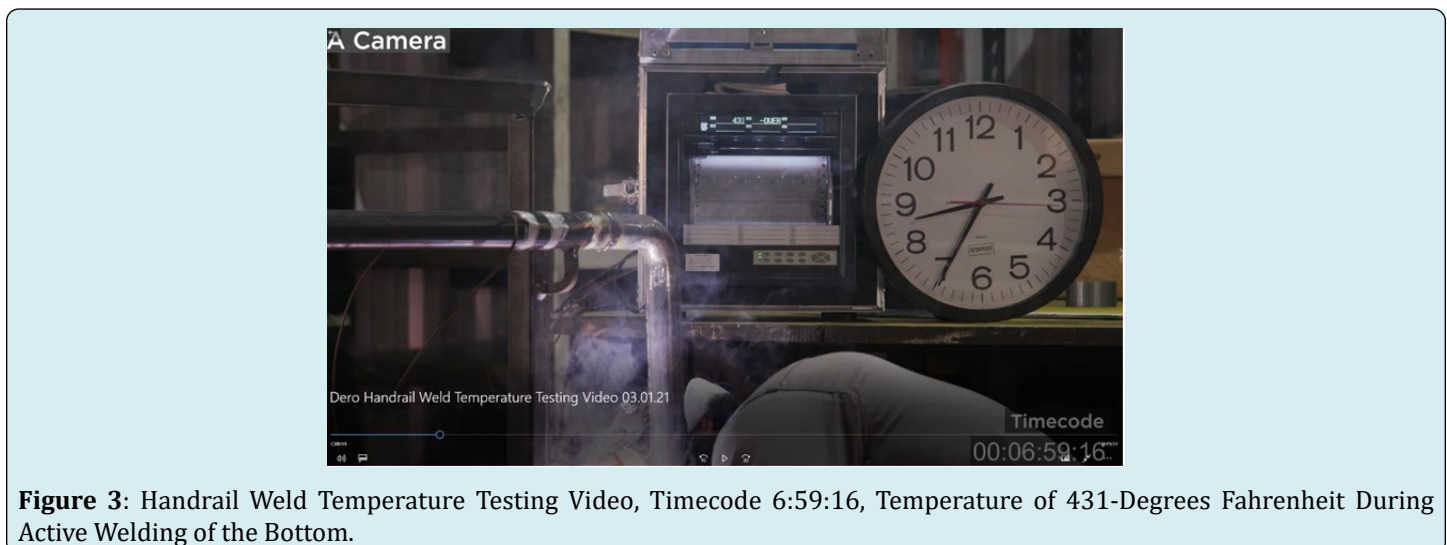
Figure 3: Handrail Weld Temperature Testing Video, Timecode 6:59:16, Temperature of 431-Degrees Fahrenheit During Active Welding of the Bottom.

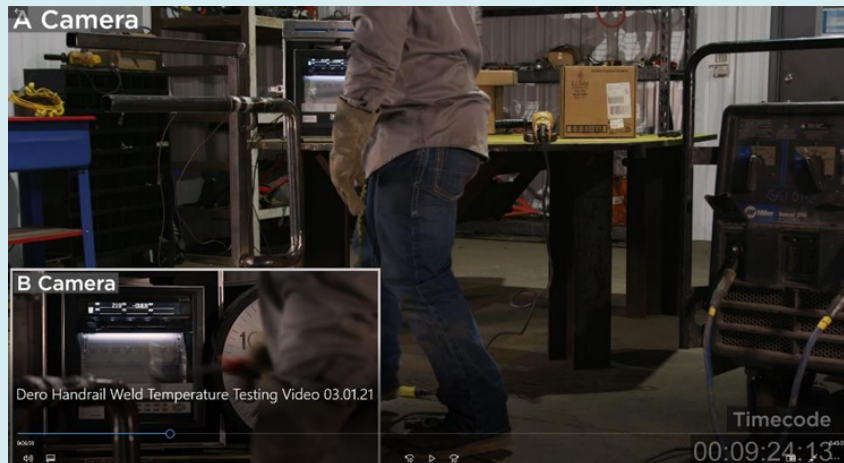
Figure 4: Handrail Weld Temperature Testing Video, Timecode 9:24:13, Temperature of 219-Degrees Fahrenheit at Approximate Finish of the First Pass of Weld Activity.

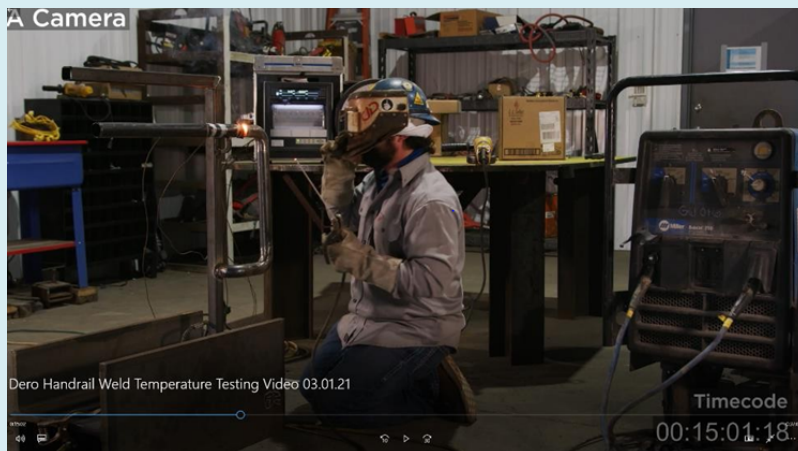
Figure 5: Handrail Weld Temperature Testing Video, Timecode 15:01:18, Temperature of 540-Degrees Fahrenheit During Second Pass of Weld Activity.

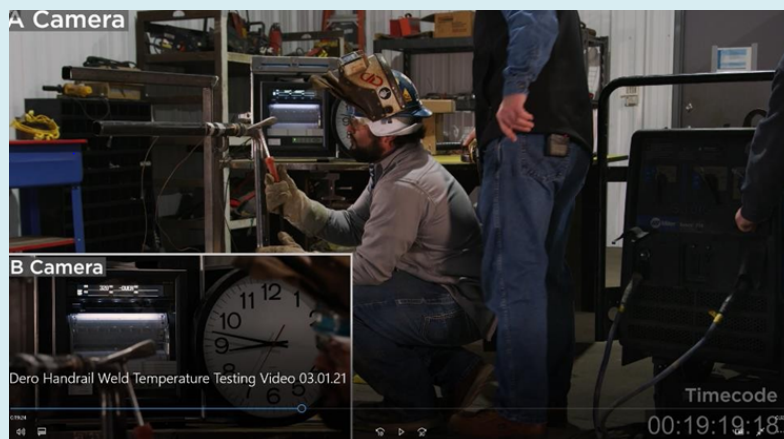
Figure 6: Handrail Weld Temperature Testing Video, Timecode 19:19:18, Temperature of 320-Degrees Fahrenheit at Completion of Welding.

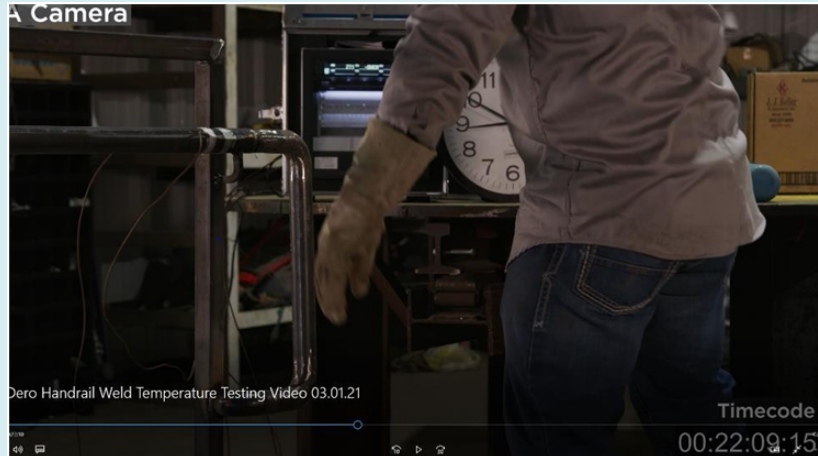
Figure 7: Handrail Weld Temperature Testing Video, Timecode 22:09:15, Temperature of 271-Degrees Fahrenheit at Completion of Grinding, Which was the Completion of all Hot Work on the Handrail.

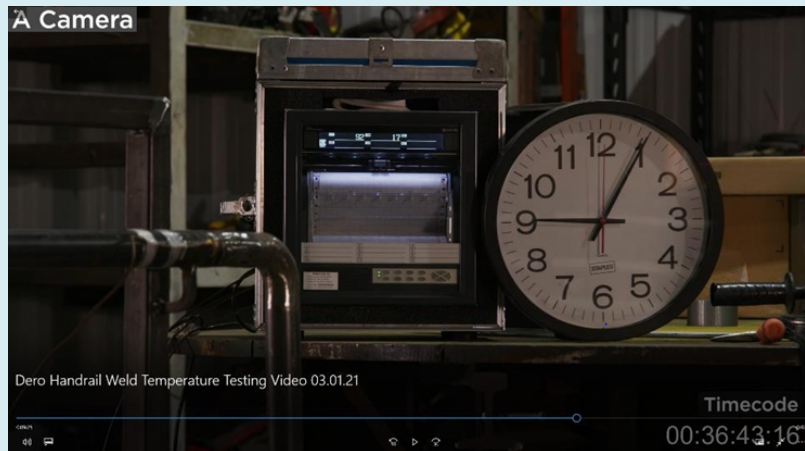
Figure 8: Handrail Weld Temperature Testing Video, Timecode 36:43:16, Temperature of 92-Degrees Fahrenheit Approximately 15 Minutes After Completion of Welding.

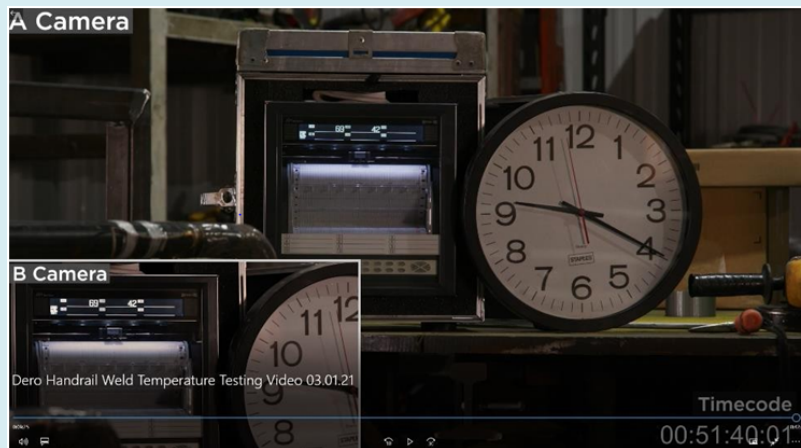
Figure 9: Handrail Weld Temperature Testing Video, Timecode 51:40:01, Temperature of 69-Degrees Fahrenheit Approximately 30 Minutes After Completion of Welding.

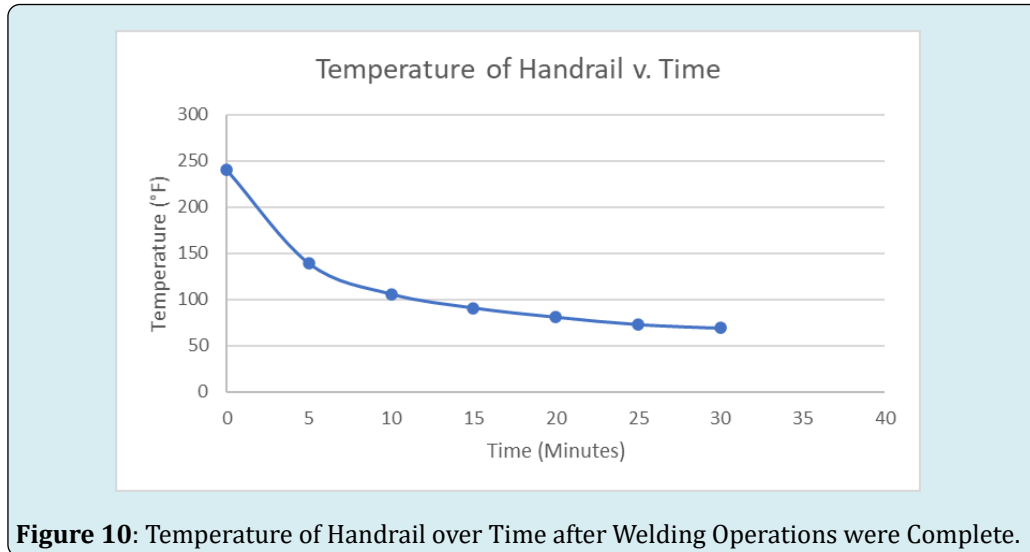
The test results demonstrated that there was fairly rapid reduction in temperature (thermal response) of the handrail after completion of the weld. Immediately after the weld was completed, the handrail temperature measured 240-degrees Fahrenheit, and within five minutes, the handrail had cooled by more than 100-degrees. Figure 10 outlines the continued decrease in temperature of the handrail over time. By 25 minutes post-weld, the temperature of the handrail had

dropped to 73-degrees Fahrenheit, at which time one of the test administrators placed his bare hand on the handrail and reported he felt no heat at all. Considering studies conducted to determine skin damage due to high temperatures, the test administrator's perception was, in fact, reasonable. By the 30-minute mark post-weld, the handrail had cooled to 69-degrees Fahrenheit, which is essentially ambient room temperature, and the test was complete.

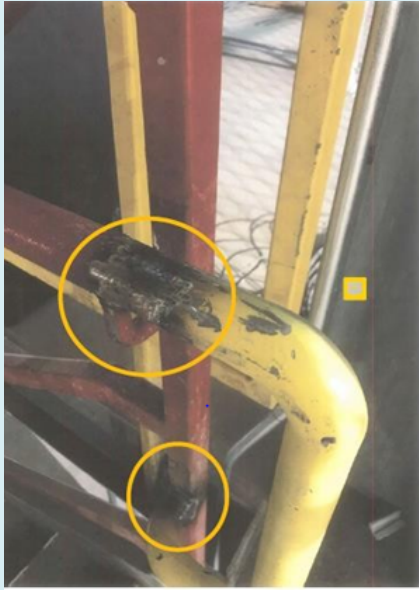
had elapsed after the welding operation was completed, thus further discrediting the hypothesis. As the distance along the rail from the weld increases, the temperature decreases substantially due to the conduction of heat from high heat areas to the portion of the rail at ambient temperature. Figure 16 shows the locations of the welded areas. As shown in Figure 12, there would be no direct access to the lower rail weld location due to the bar configuration; therefore, the testing conducted accurately positioned the thermocouples within the vicinity of the weld on the top of the top handrail, but not on the weld itself.

Figure 12: Photograph of Handrail with the Welded Areas Circled in Yellow.

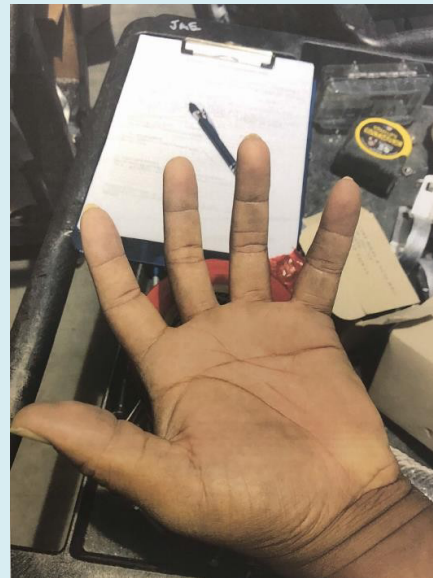
The site safety supervisor reported that the claimant's alleged burn did not require any treatment or first aid, which was reiterated in the incident accident investigation form. Additionally, the photograph of the claimant's hand (Figure 13) that was included as part of the incident report showed no visible signs of injury or burn, further validating the findings of the tests on the exemplar handrail.

Figure 13: The Photograph Taken of the Claimant's Hand after the Incident Showed no Signs of Injury.
