# The Characterization of Firing Squad Execution Walls Part II

## Assessment of the Walls of Fort Platte Saline

### Case Report

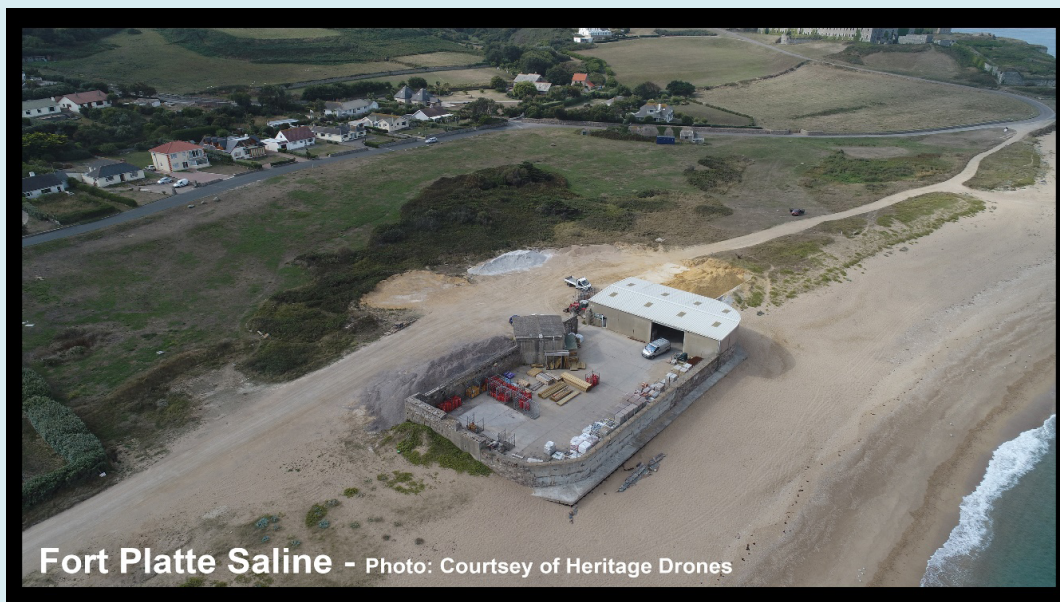
**Figure 1a:** An Aerial Drone Photograph of FPS. This Photograph is Courtesy of Heritage Drones.

A study and analysis of the ballistics damage observed, documented, and collected during a visit to a small fort located on Alderney Island. Figure 1a is a recent drone photograph taken of Fort Platte Saline (FPS), the subject fort, showing its location on the central, Northern tip of Alderney Island. Figure 1b is an enlarged photographic image made from the original aerial photograph provided by Heritage Drones. A clear, non-obstructed, highly detailed, overhead view of FPS is evidence of its current use and condition.

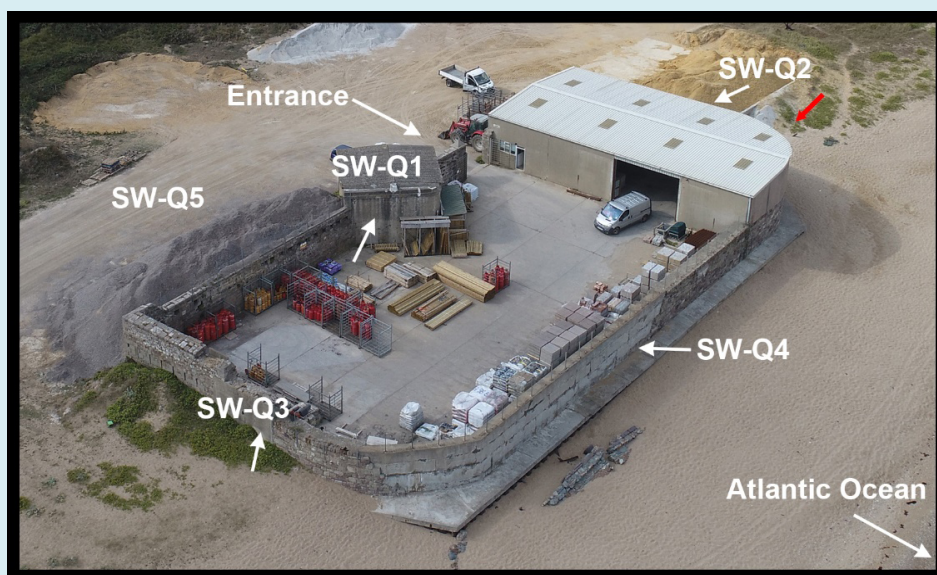
**Figure 1b:** An Enlargement of FPS Made from the Original Aerial Drone Image, Showing the Five Subject Questioned Walls (SW).

The former fort is used as a construction materials storage site. The first search revealed that three of the four exterior walls making up FPS outer structure show obvious ballistics damage to their outer surfaces. The only interior wall inside FPS that had ballistics damage was designated SW-Q1, while the four exterior walls of FPS were designated SW-Q2, SW-Q3, SW-Q4, and SW-Q5.

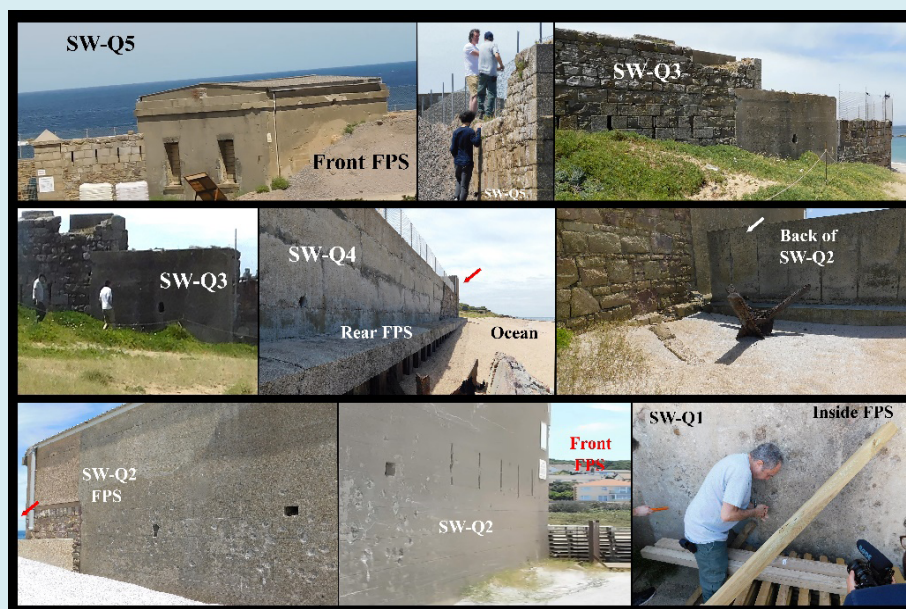
**Figure 2:** Upon Arrival, a Preliminary Walk-Through of the Subject Location is Conducted. The Searching Procedure is Conducted by the Team in Order to Ascertain the Condition of the Fort's Structure and Locate Any Potential Probative Evidence.

Upon first arriving at FPS, a grid search pattern was initially employed to conduct the preliminary walk-through of the entire fort. The search was conducted to ascertain the condition of the fort's structure, and to locate any potential probative evidence that would assist the forensic examiners to determine how the damage to the Fort's walls occurred. Figure 2 shows eight stages of the initial walk-through searching process as well of the locations of the subject walls.

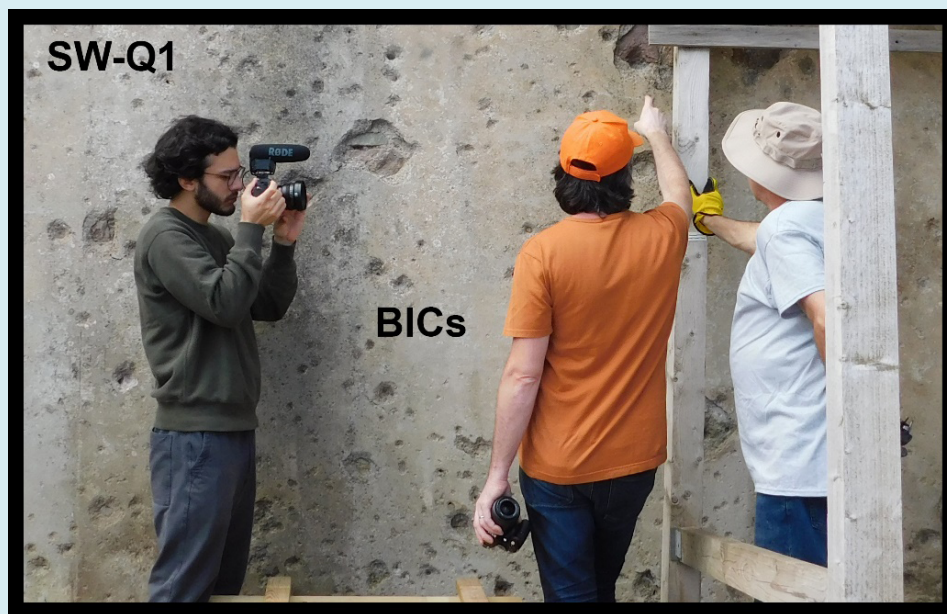
**Figure 3a:** Examination and Documentation of the Wall Designated SW-Q1.

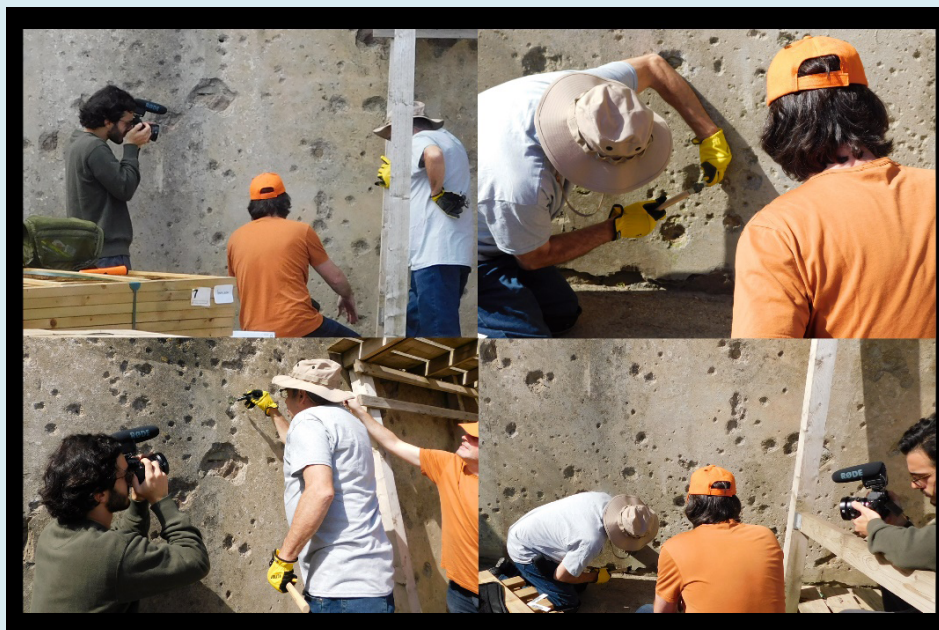
**Figure 3b:** Searching SW-Q1 for Possible Embedded Projectiles and Other Categories of Trace Evidence Such as Pieces of Projectiles, Metal Fragments, Pieces of Textile, and Gunshot Residue. One of the Team's Members, a Professional Photographer/Videographer/Film Maker, Meticulously Recorded and Documented the Entire Process.

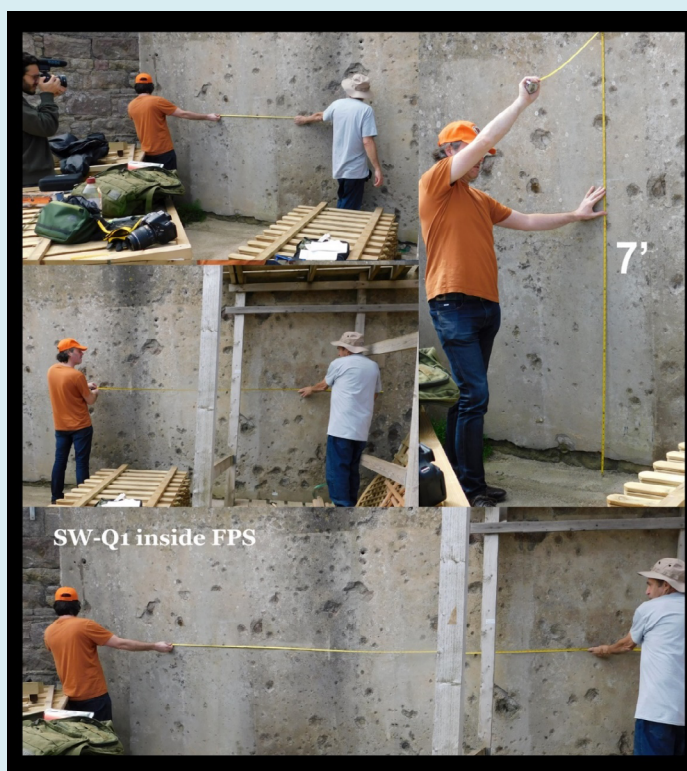
**Figure 3c:** Documentation and Measurements of SW-Q1's, Height, Length, and Overall Appearance.

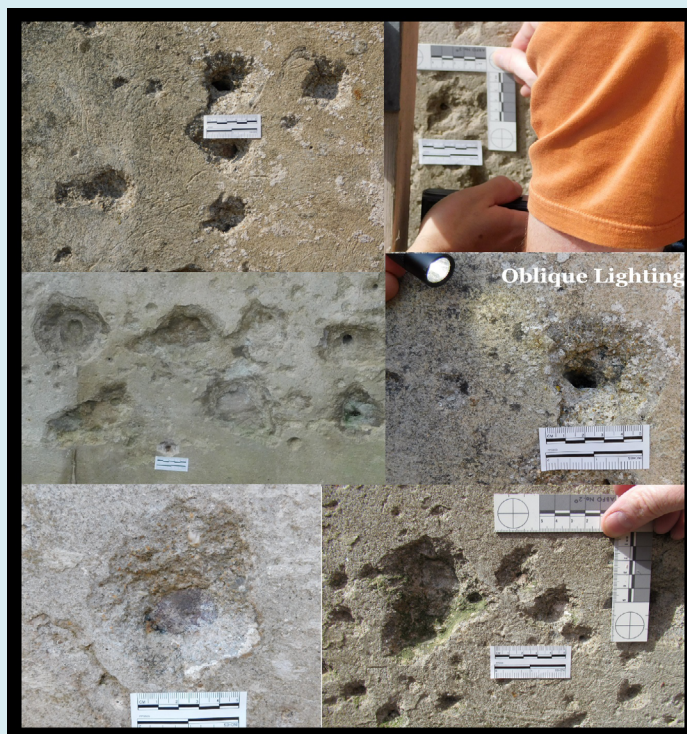
**Figure 3d:** Measuring the Diameters of a Selection of Bics Present on SW-Q1 in Order to Assess their Size, Shape, and Structure. All these Bics were Examined for Trace Evidence .

shaped, inverted cone structures, with a central impact zone radiating upwards towards the wall's outer surface. The BICs vary in size and depth, with an average diameter of 1.5" to 6.0" inches as seen in Figure 3d, Figure 4, Figure 5b, Figures 8a-8b, and Figure 9. Based on the controlled experiments conducted using a WW2 Mauser and WW2 ammunition, the 6.0-inch impacts were more likely missed shots, perhaps in between the individuals standing in front of the wall, whereas the smaller size impacts, from 1.5 inches to just under 6 inches, were from bullets that first hit the individuals standing in front of the wall. This hypothesis was confirmed during the controlled experiments by the use of ballistic gelatin in front of the test walls. Combining the results of the controlled experiments and the pattern of the impact marks on the walls, the authors believe those walls were used for executions during the occupation.

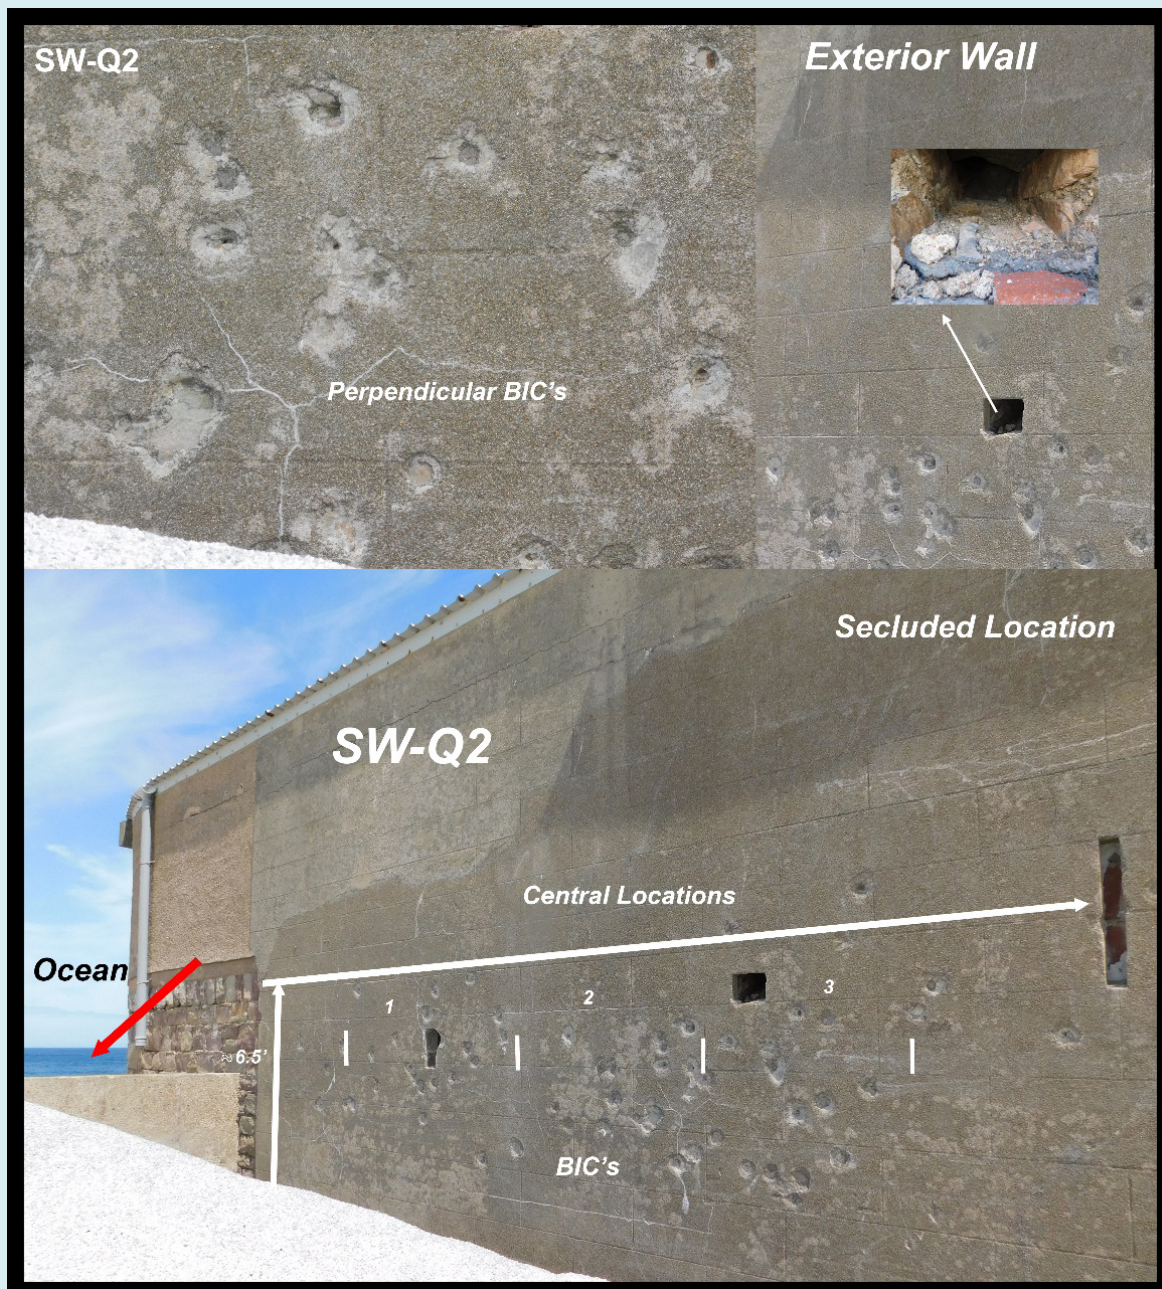
The examination and documentation of the ballistics damage present on SW-Q2 the exterior, Note the presence of a FSEWP towards the lower portion seen in Figure 4. SW-Q2 is situated in a hidden and obscure, secluded area, with a small wall position between the ocean and the front

of FPS. Note the presence of a white line approximately 6.5 feet off the ground's surface, running along the wall, parallel to the ground with a large number of round shaped BICs concentrated in the central portion of SW-Q2.

**Figure 4:** Examination and Documentation of the Potential Probative Evidence on this Exterior Wall Designated SW-Q2.

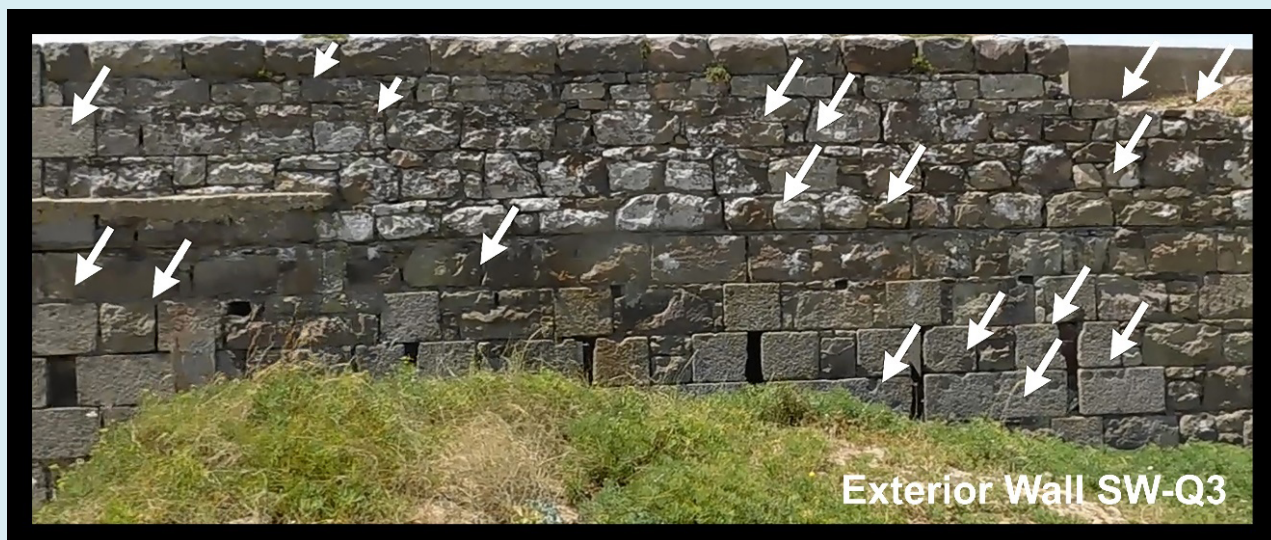
Examination and documentation of the ballistics damage present on FPS's masonry wall designated SW-Q3. Figure 5a shows that there are a large number of BICs (marked with a white arrow) present on the wall's outer, exterior, concrete block, masonry, and stone surfaces as well as damage to

the top portion of the wall, marked with a black arrow. The adjacent concrete wall shown in Figure 5b exhibits a large number of randomly distributed BICs (marked with a black x) present on this section of the exterior wall of FPS. Note the lack of a FSEWP on either side of this wall.

**Figure 5a:** Examination and Documentation of the Potential Probative Evidence on the Exterior FPS Wall Designated SW-Q3. A White Arrow Designates the Presence of Bics and Considerable Ballistics Damage to the Wall's Outer Surface. Note the Lack of a FSEWP on this Concrete and Stone Wall's Outer Surface.

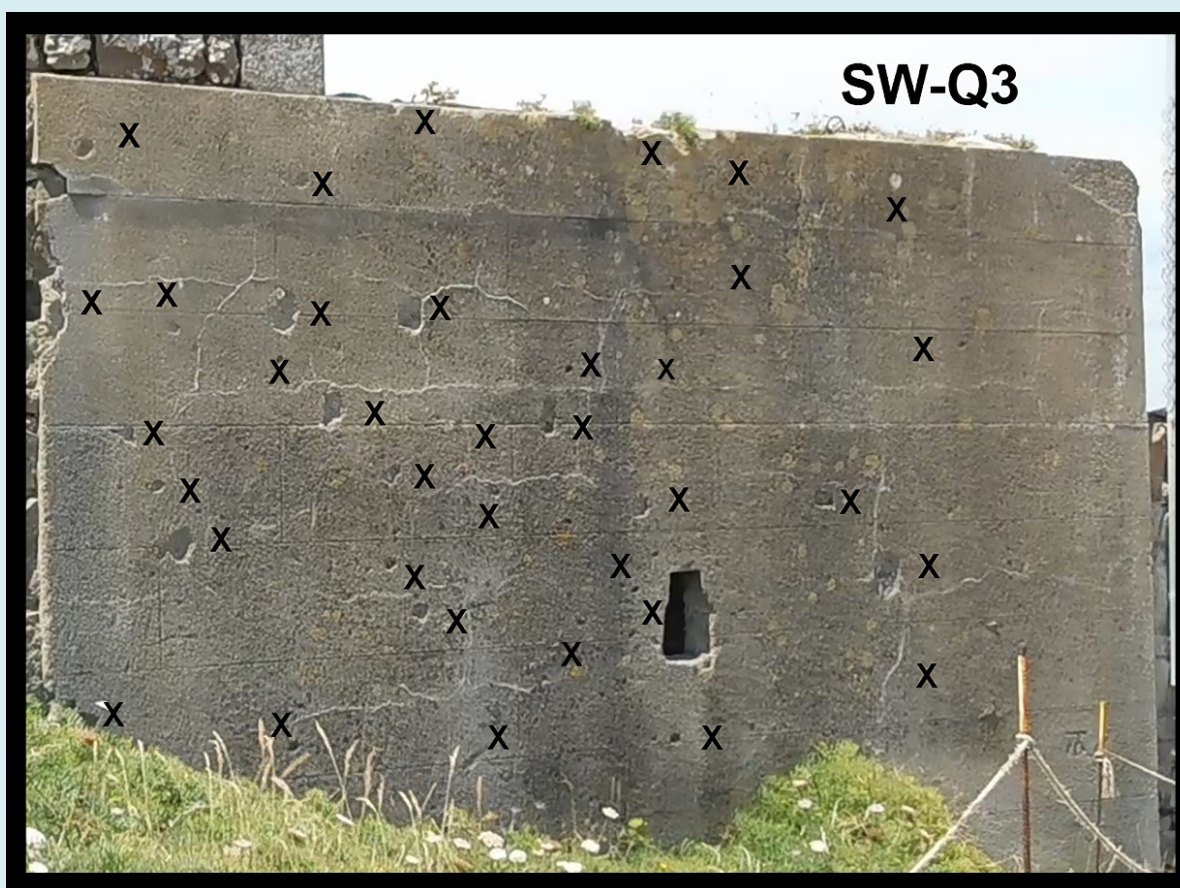
**Figure 5b:** Documentation of a Large Number of Randomly Distributed BICS (Marked with a Black X) Present on the Exterior Wall of FPS Designated SW-Q3. Note the Lack of a FSEWP on this Masonry Wall's Outer Surface.

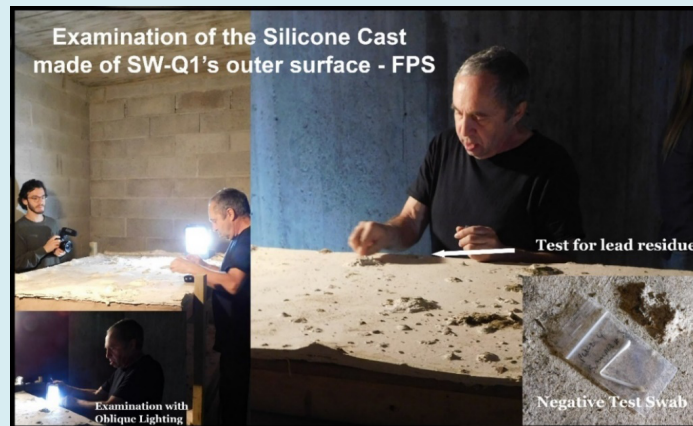
The examination of a silicone mold made prior to this forensic investigation is shown in Figure 6a. Portions of the mold were examined and tested for various forms of trace materials including residues of lead and copper all of which could be used to help reconstruct the events of the past. In all, nine questioned items of trace evidence were collected

**Figure 6a:** Shown is the Oblique Lighting Examination and Search of a Silicone Mold of the SW-Q1 Located inside FPS for Trace Evidence. Areas of the Mold are Tested for Lead (Sodium Rhodizonate) and Copper (Rubeanic Acid) Residues with Negative Results.

The questioned specimens Q1-Q9 collected from the silicone mold of SW-Q1 in FPS were examined macroscopically, as well as with wet chemistry reagents for lead and copper residues, all of these items were found to be of no value to this investigation. The metal fragments designated Q10 and Q11 were submitted for advanced instrumental analysis. Each metal fragment was consistent with originating from a lead projectile.

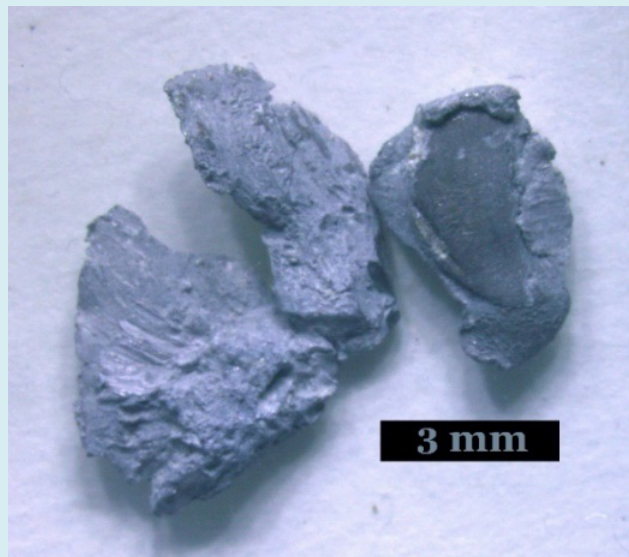
Q1. The questioned metal fragments collected from a nearby "Anti-Tank Wall" just to the East of Fort Platte Saline. The questioned metal fragments were designated Q10 and Q11, see Figure 6b. All questioned items transferred to forensic laboratories for future analysis.

**Figure 6b:** Lead Bullet Fragments from the Platte Saline "Anti-Tank" Wall East of the Fort, Later Identified with XRF Spectroscopy.

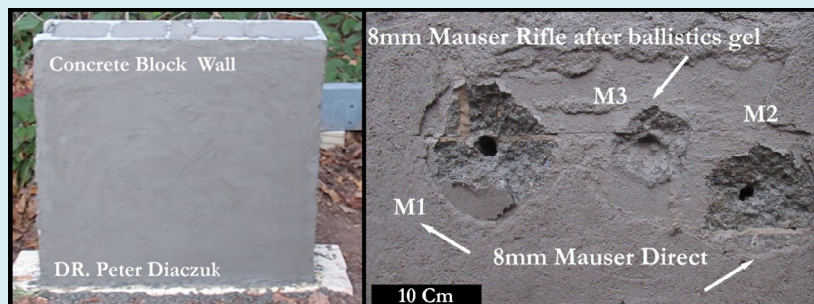
WWII 9mm Luger pistol round or a genuine WWII German army issue 8mm WWII Mauser rifle rounds into concrete, three small test walls were prepared. Test wall one (TW1) a concrete block wall measuring 34" H, 32" W and 8" thick, reinforced with concrete poured into the blocks' cores, and

**Figure 7a:** Test Wall 1: On the Left, is a Concrete Block Wall (Coated with Rendering Mortar) into which Three 178 Gr Mauser Rifle 8mm Rounds were Fired from Forty Feet (40'). On the Right, M1 Designates The  $\approx 5''$  Diameter, Inverted Cone Shaped, Circular Crater Produced by the First 8mm Rifle Round. On the Right, M2 Designates the  $\approx 5''$  Diameter, Inverted Cone Shaped, Circular Crater Produced by the Second 8mm Rifle Round. In the Middle, M3 Designates the  $\approx 3''$  Diameter, Inverted Cone Shaped, Circular Crater Produced by the Third 8mm Rifle Round which First Passed through a Block of Ballistics Gel (Perma-Gel™) Before Striking the Concrete Block Wall.

TW1: On the right, M1 designates the  $\approx 5''$  diameter, inverted cone shaped, circular crater produced by the first 8mm Mauser rifle round. On the right, M2 designates the  $\approx 5''$  diameter, inverted cone shaped, circular crater produced by the second 8mm rifle round. In the middle, M3 designates the

$\approx 3''$  diameter, inverted cone shaped, circular crater produced by the third 8mm rifle round which first passed through a block of ballistics gel (Perma-Gel™) before striking the concrete block wall. The ballistics gel is designed to simulate the passage of a projectile through a human body (Figure 7a).

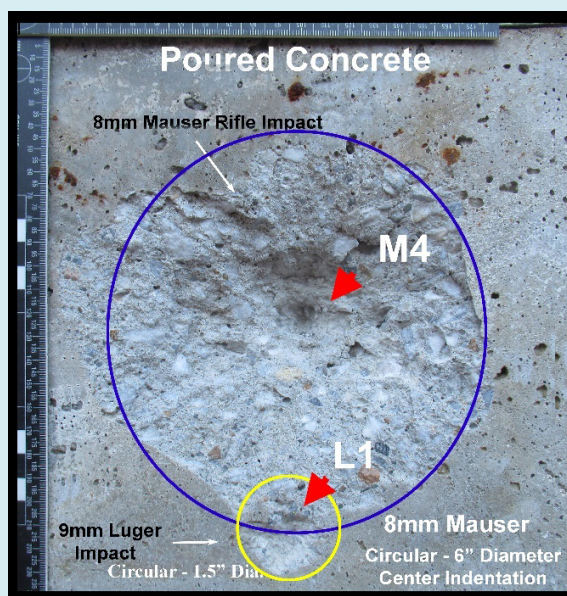
finished with a skim layer of fresh concrete and allowed to cure, see Figure 7a. Next, a second small test wall (TW2) was constructed by pouring concrete into a metal form, allowing it to cure see Figure 7b, a third small test wall (TW3) constructed from a block of granite skim coated with a fresh

**Figure 7b:** Test Wall 2: A Poured Concrete Wall 2' High X 1.5' Wide X 1.0' Thick Weighing  $\approx 500$  Lbs. Depicting Two Bics. In the Middle, M4 Designates, the  $\approx 6''$  Diameter, Inverted Cone Shaped, Circular Crater Produced when a WWII German Mauser Rifle 178 Gr, 8mm Round Fired Directly into it From a Distance of 40'. On the Bottom, L1 Designates the  $\approx 1.5''$  Diameter, Inverted Cone-Shaped, Circular Crater Produced when a WWII German Luger 9mm Pistol Round Fired Directly into the Wall from a Distance of 40'.

TW2: A poured concrete wall 2' high x 1.5' wide x 1.0' thick weighing ≈500 lbs. depicting two BICs. In the middle, M4 designates, the ≈6" diameter, inverted cone shaped, circular crater produced when a WWII German Mauser rifle 178 gr, 8mm round fired directly into it from a distance of 40'. On the bottom, L1 designates the ≈1.5" diameter, inverted cone-shaped, circular crater produced when a WWII German Luger 9mm pistol round fired directly into the wall from a distance of 40' (Figure 7b).

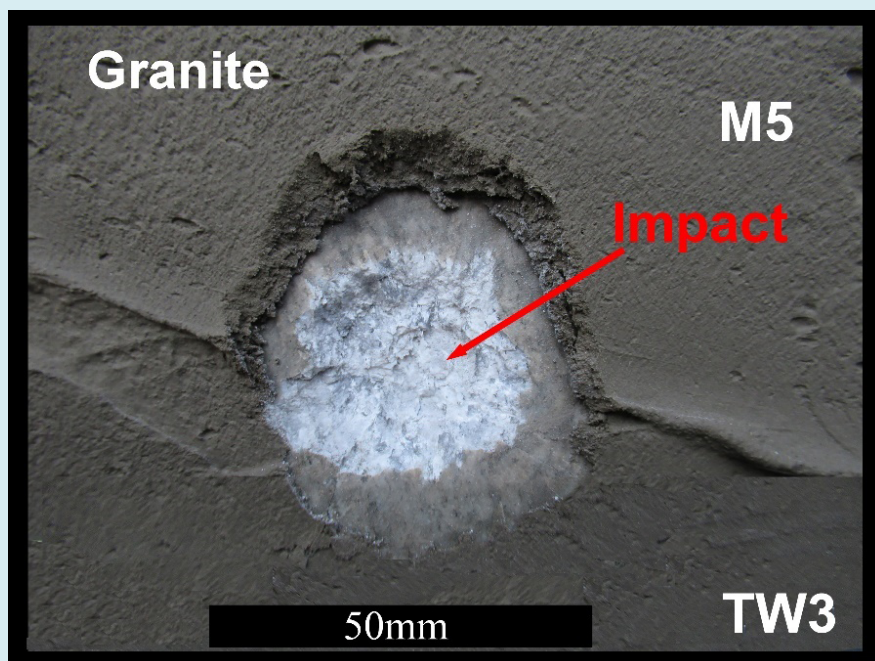
TW 3: A metamorphic, granite, gneiss rock slab coated with rendering mortar made with sand from the beach adjacent to FPS. Shown is M5, a BIC and its impact zone, present on the surface of the granite block created by an 8mm, 178 gr, Mauser rifle round fired from 40' at a 90o angle directly through a block of ballistics gel before striking the granite block. The same direct shot without ballistics gel was made from 20' with no apparent changes in the appearances of the second BIC (Figure 7c).

**Figure 7c:** Test Wall 3: A Granite Slab Coated with Rendering Mortar Made with Sand from the Beach Adjacent to FPS. Shown is a BIC, Present on the Surface of the Granite Block Created by an 8mm, 178 Gr, Mauser Rifle Round Fired from 40' at a 90o Angle Directly through a Block of Ballistics Gel Before Striking the Granite Block.

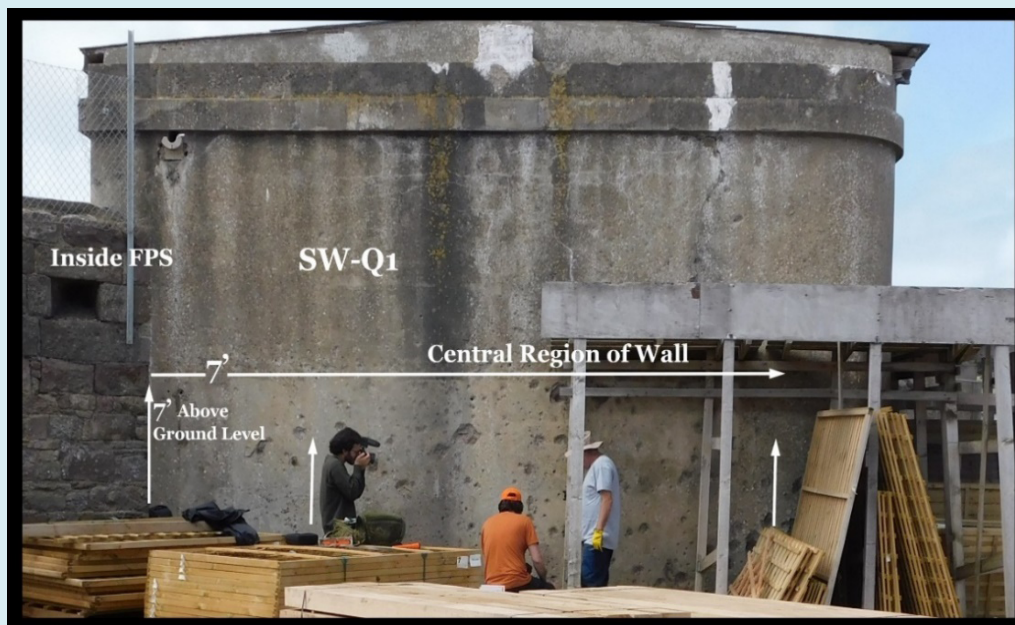
The BIC patterns on the three questioned walls designated SW-Q1, SW-Q2, and SW-Q3 were each evaluated as follows. Two of the subject walls SW-Q1, and SW-Q2 were found to have recurring FSEWP previously described. Both walls contain a copious number of bullet impact craters

(BICs), concentrated in their central region, arranged in a straight line,  $\approx 7'$  above each wall's footing, running parallel to the wall's base, thus meeting the criteria set forth in the authors' hypothesis for the designation of FSEWP.

**Figure 8a:** A View of SW-Q1 Clearly Showing the Structured FSEWP of Bics Running Along the Wall Parallel to the Ground.

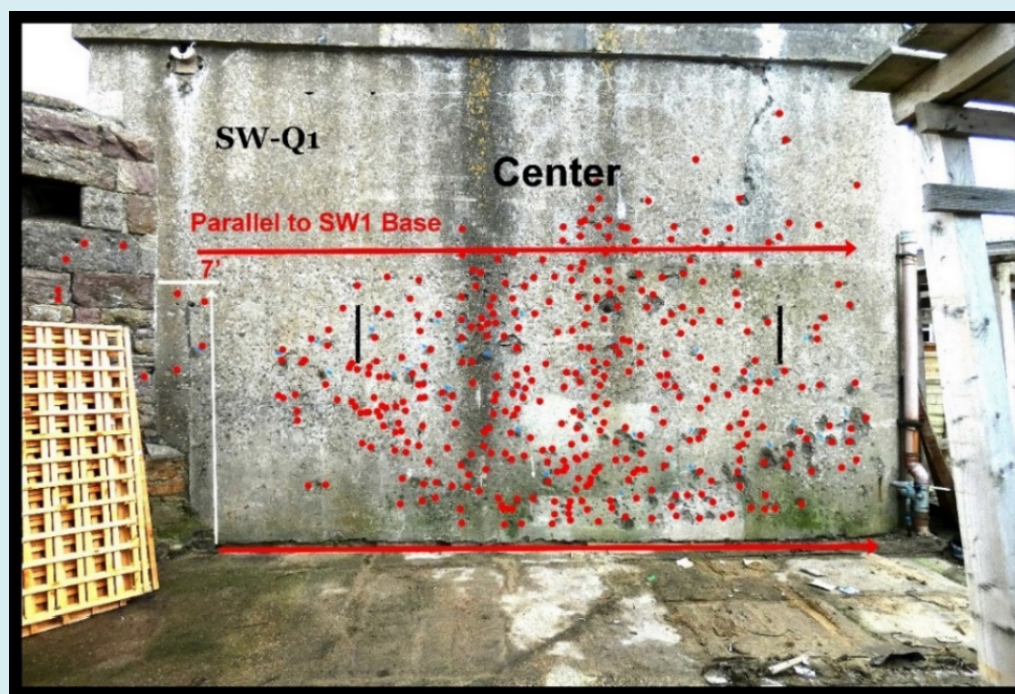
**Figure 8b:** A View of the Interior Wall SW-Q1 Photographed Before the Silicone Mold was Made. The Majority of BICS are Marked with a Red Dot. The FSEWP Present on SW-Q1 is Plainly Seen.

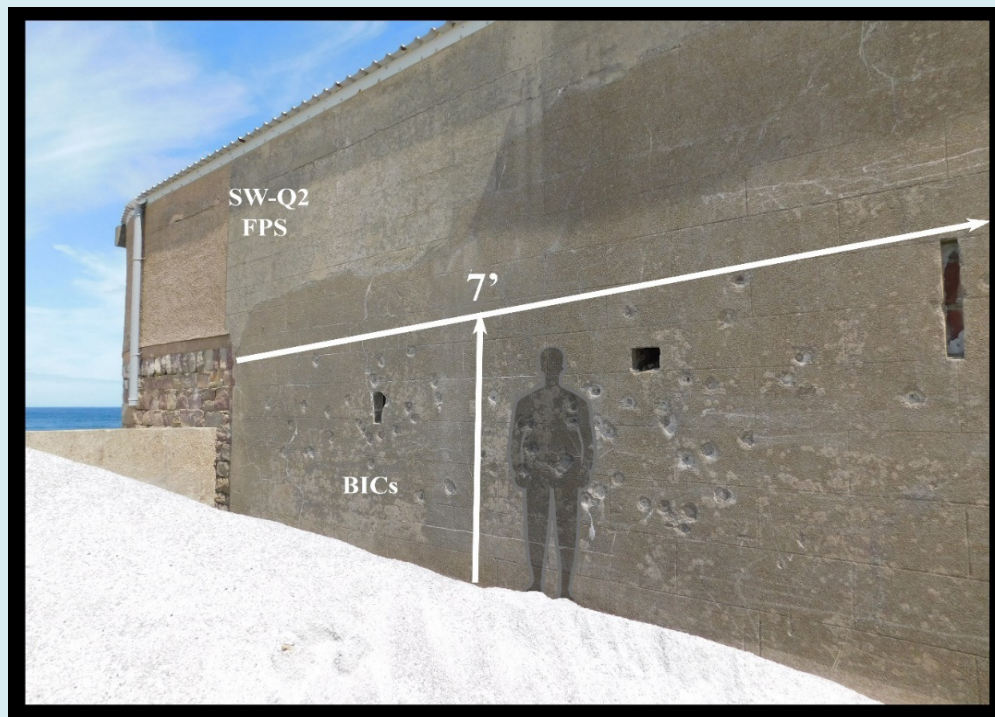
**Figure 9:** A View of SW-Q2 Clearly Showing the Physical Evidence Forming a FSEWP of BICS Running Along the Wall Parallel to the Ground with the Outline of an Average Size Human Adult Male.

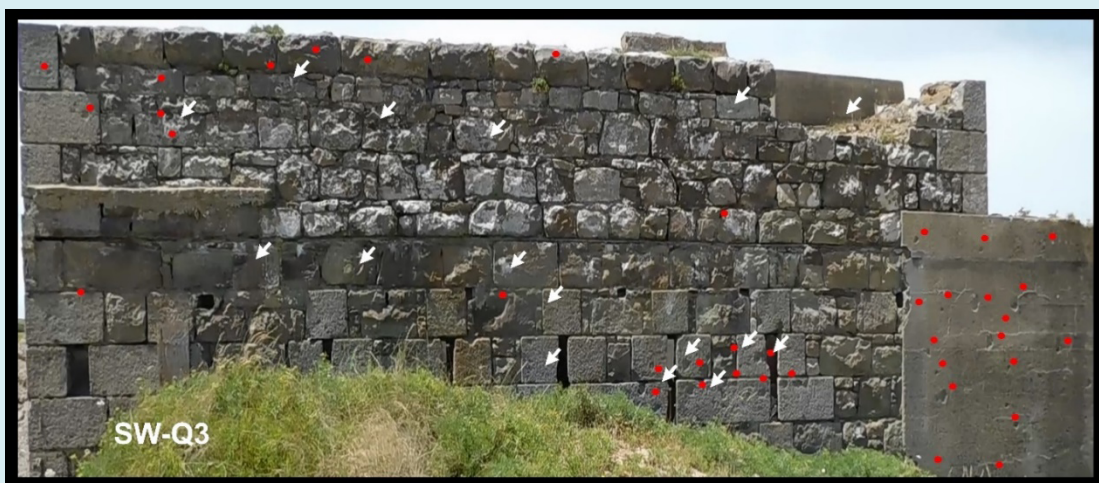
The questioned wall designated SW-Q3 also has a profuse quantity of BICs. However, SW-Q3 contains no recognizable pattern, all of the BICs are randomly distributed over the wall's entire surface. Many of these BICs are oval, not round

shaped, which denotes that the bullets struck the surfaces from above, and at an angle greater than 90° as seen in Figure 10. Bullets on a downward trajectory, after traveling a long distance, would leave such non-circular impact marks.

**Figure 10:** A View of SW-Q3 Clearly Showing the Bics Random Distribution Over the Entire Wall Surface, Most of the Bics are Marked with a Red Dot or a White Arrow. Once Again, Note the Lack of a FSEWP on this Concrete, Stone Wall's Outer Surface.
