Biomaterial Phenomena in Hip Joint Endoprostheses

Abstract

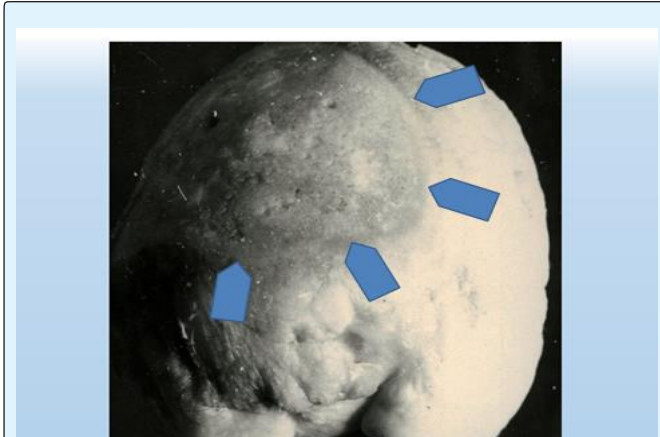
Figure 1: Femoral head with an area of completely destroyed cartilage (arrows).

Among the causes of joint dysfunctions, including hip joint, are changes in the joint cartilage. One of the causes of such changes is cartilage biomineralization occurring as a result of crystallization in structurally defective collagen (Pawlikowski 2017, in print). Said biomineralization leads to changes in the properties of cartilage collagen, the effect of which is formation of areas of increased hardness in cartilage that eventually result in complete destruction of cartilage and often

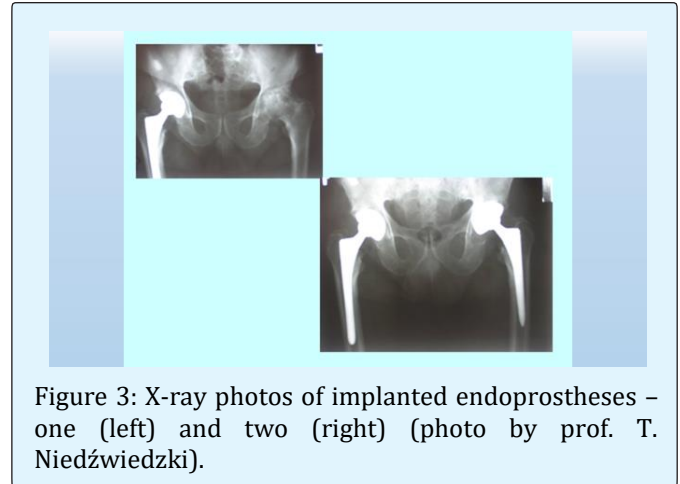
Figure 3: X-ray photos of implanted endoprostheses – one (left) and two (right) (photo by prof. T. Niedźwiedzki).

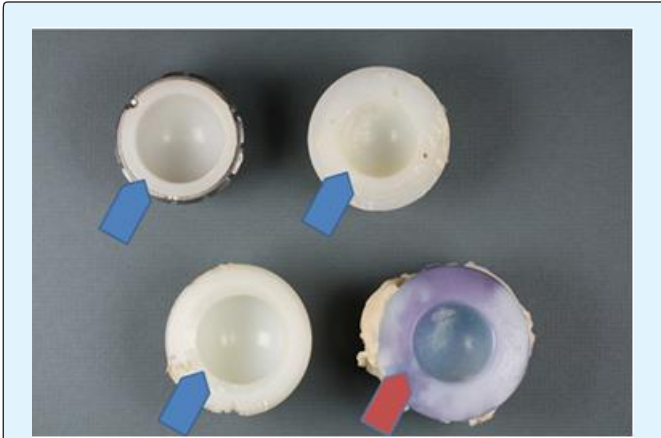
Figure 4: Studied acetabula. New acetabula that were unused for a long time (blue arrows). One of the acetabula taken out of the joint after a few years of functioning (with some fixing cement, red arrow).

In the studies of acetabula, particular attention was paid to those that had been unused for a long time, to see if any changes occurred in them due to their "aging". Some new acetabula have a distinctive surface in sockets, which is the result of polymer processing and formation of the socket (Figures 4 & 5A).

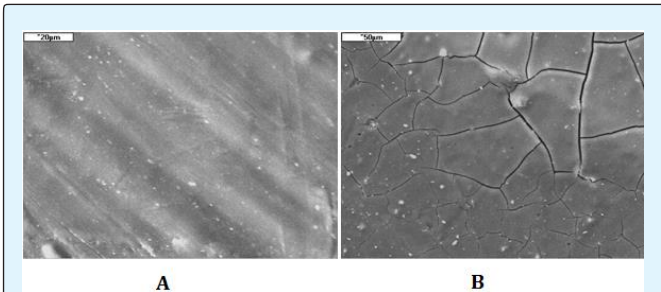
Figure 5, A: Surface of the acetabulum socket processed by machining; SEM. B: Surface of old, unused acetabulum affected by the process of polymer aging, leading to formation of microcrystalline domains and cracks of 3-4 μ m width; SEM.

Studies of acetabula that have been waiting to be implanted for a long time indicate that they can be affected by the process of polymer aging, which may lead to formation of numerous cracks (Figures 5 & 6). Those cracks are absolutely invisible to the naked eye. Their consequence – when implanted – may be the possibility of breaking off of polymer fragments that may then get into the working zone between the endoprosthesis head and socket.

The above studies indicate that acetabula should be checked for defects before being implanted – preferably by microscopic observation.

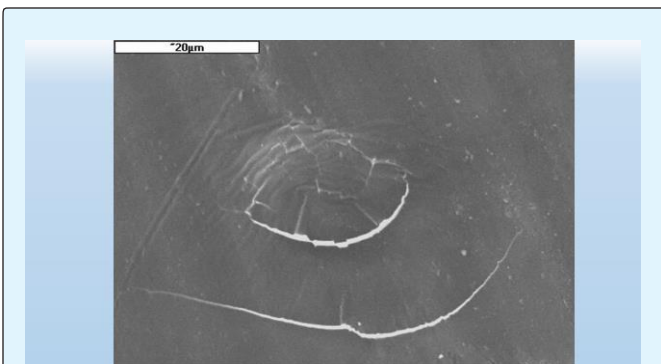
Figure 6: Image of the inside of acetabulum socket affected by structural changes due to the aging of polymer. Visible cracks of 1-2 μ m width SEM.

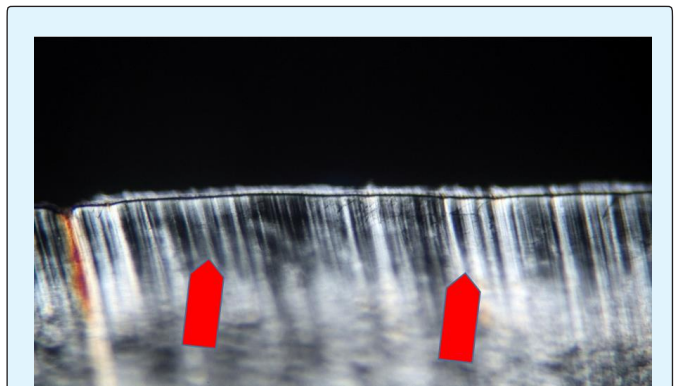
Figure 7: Microscopic image of the cross-section of a new acetabulum. The surface layer (arrows) shows no differences from the deeper parts of the acetabulum. Polarizing microscope, polaroids X, magnification 180 x.

The process of machining the socket in acetabula causes changes in very thin surface layer and they are insignificant. Under the microscope we can see that the part designed to take the load (the socket of the acetabulum) is microscopically the same as its other parts (Figure 7).

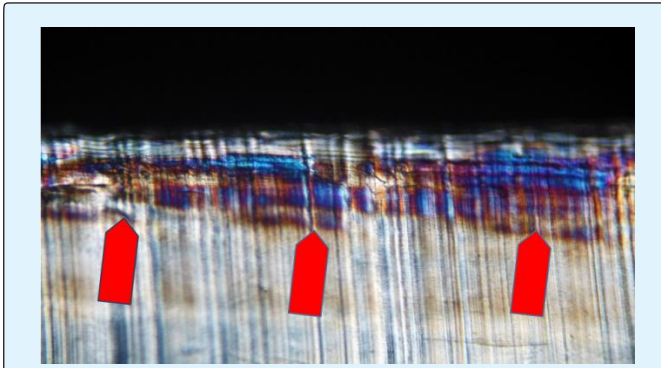
Figure 8: Microscopic image of the cross-section of a worn-out acetabulum. The surface layer (arrows) shows differences from the deeper parts of the acetabulum. It shows as changes in the interference colors of polarized light. Polarizing microscope, polaroids X, magnification 180 x.

Acetabula taken out of the joint after a longer (several years) usage show in the same place changes of interference colors (Figure 8), which are connected with changes of the atomic structure of the polymer. At this point in research, it is difficult to say what the changes are. Preliminary observations indicate that the process is irregular and leads to increasing the hardness of polymers that build the socket. The phenomenon may promote cracking of the surface layers of the sockets and shifting the resulting fragments into the joint space.

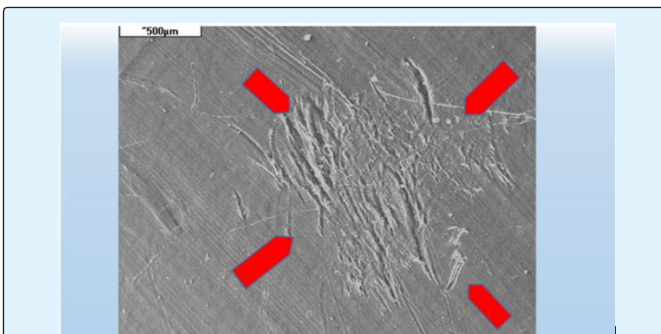
Figure 9: “Oscillating” marks of socket surface damage as a result of movement of the damaging fragment. SEM.

In case when some foreign objects (bits of steel or micro bits of slags from the steel element) get into the joint space of the endoprosthesis, the damage of the socket surface have a distinct appearance and clearly “oscillating” character.

Resulting scratches show that the tiny destructive element moved over the socket surface back and forth. The effect of this phenomenon is not only damage to the surface of the socket, but also introducing small bits of plastic into the joint surface of the endoprosthesis (Figure 9).

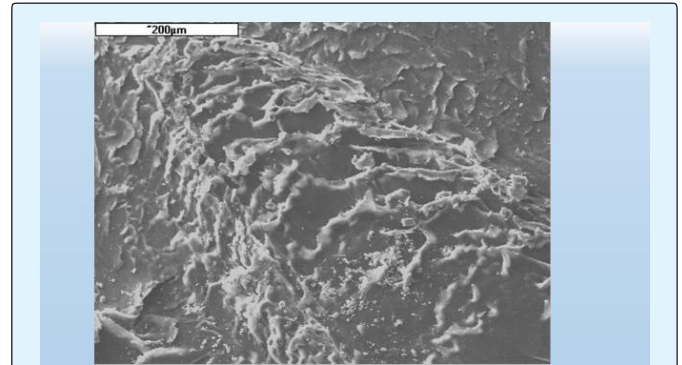
Figure 10: Marks caused by rubbing off of the socket surface of the endoprosthesis resulting from its long-lasting load. SEM.

Another effect of deterioration of the socket surface is visible under the scanning microscope as rubbing off of its surface. That process, related to the load on the joint and resulting changes in the structure of the polymer, causes distinct marks to appear (Figure 10). Their formation leads also to breaking off of small bits of polymer from the socket and their introduction into the joint space of the endoprosthesis. Further relocation of those propylene micro grains cannot be ruled out.

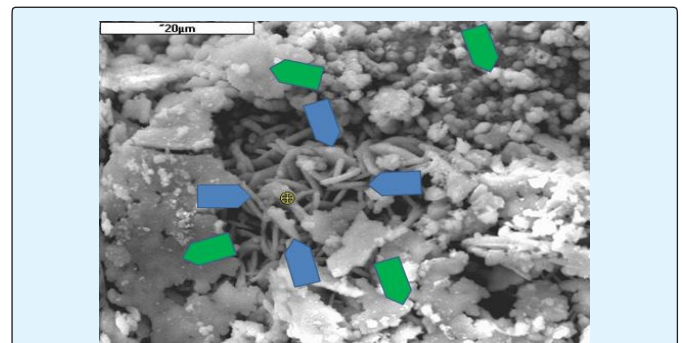
Figure 11: Oxalates (blue arrows) among carbonates (green arrows), crystallized on the socket surface of hip joint endoprosthesis. SEM.

A special case is crystallization of various substances such as oxalates, carbonates or phosphates in the joint space of the endoprosthesis. Their formation is usually connected with various dysfunctions outside of joints (kidney function disorders etc.).

Minerals crystallizing in the joint space and its area often have significant hardness, and in spite of their crystals being as small as 20-30 µm (Figures 11 & 12), they may wreak havoc in a functioning endoprosthesis. They act like grains of sand hindering or even preventing the functioning of the endoprosthesis. The result may also be swelling of the joint and other problems.

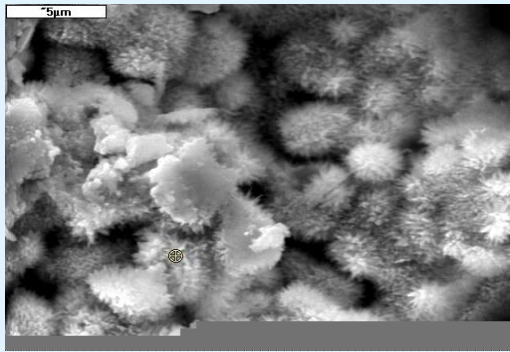
Figure 12: Oxalate crystals crystallized on “non-working” part of the socket of hip joint endoprosthesis. SEM.

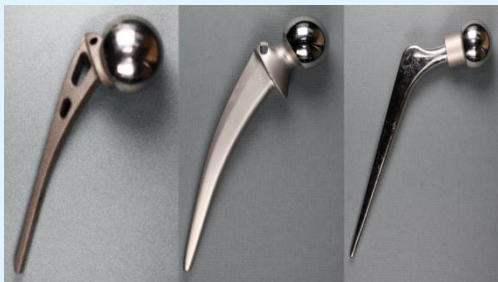
Figure 13: Cleaned metal parts of endoprostheses studied after being removed from patients during endoprosthesis replacement.

Tests were carried out on heads of selected endoprostheses (Figure 13) that were removed from Patients during the procedure of endoprosthesis replacement. “Working” fragment, which bore the most load, were cut from the heads of those endoprostheses (Figure 14).

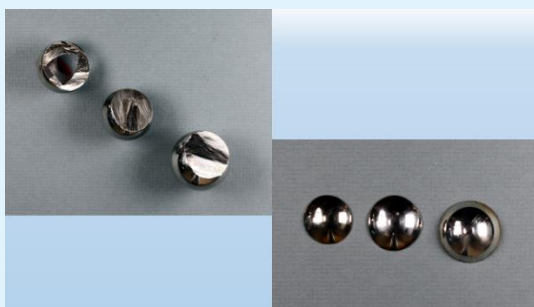
Figure 14: Fragments of cut heads of the endoprostheses. Left – view from the side of endoprosthesis; right – view from the side of the joint.

Studies showed that steels used in production of the endoprostheses are iron-chromium-cobalt steel (heads 1, 2, left) and iron-chromium-manganese steel with admixture of nickel (head 3, right). Their chemical analyses carried out with EDS method are shown in Figures 15 and 16.

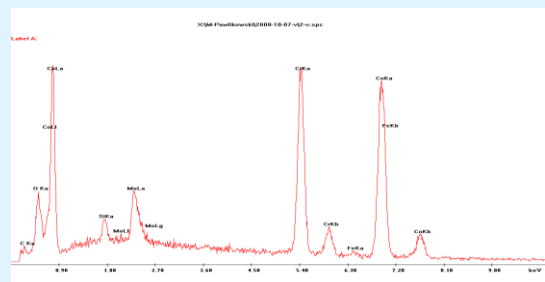
Figure 15: EDS energy spectrum of steel from head 1 (Figure 14).

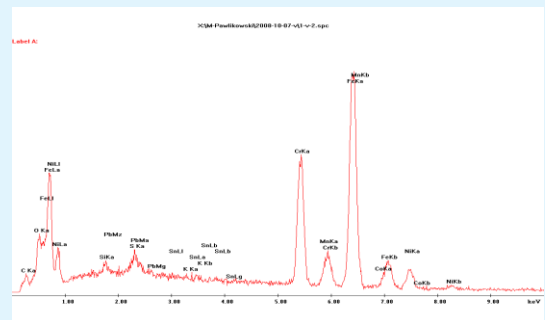
Figure 16: EDS energy spectrum of steel from head 3 (Figure 14).

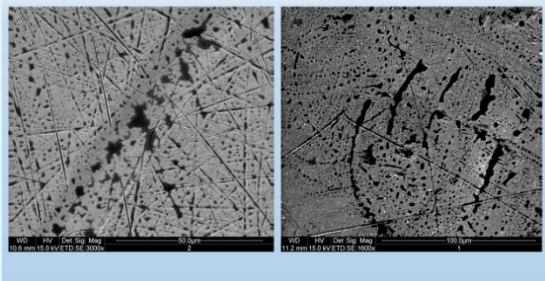
Figure 17: Structure and patterns of microvoids in the heads of the endoprostheses. Left – head of endoprosthesis 1 (Figure 14); right – head of endoprosthesis 3 (Figure 14). SEM.

Studies showed that tested steels from the heads of endoprostheses differ not only in chemical composition, but also in structure. Despite their reflective shine, all of them are fine-crystalline and they have different porosity, including different configuration of micropores (Figure 17).

It affects the functioning of the joint of endoprosthesis, including the erosion of the plastic socket surface, because the edges of the voids are exceptionally sharp and can cut the surface of the socket under load.

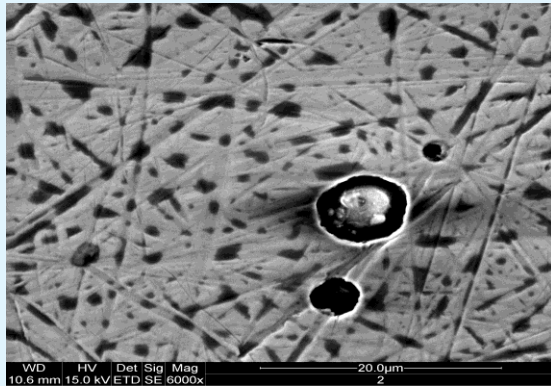
Figure 18: Microslag and a hole remaining after a microslag was torn out in fine-crystalline steel of chromium-nickel head of the endoprosthesis.

During observation of endoprostheses heads surfaces, carried out under scanning microscope, fine silicate and aluminosilicate microslogs were found (Figures 17 & 19). When they get torn out of the steel during the endoprosthesis functioning and find their way into the joint space, they cause significant damage. It can be seen especially on the surface of the soft, plastic socket, but due to their significant hardness, they also damage the surface of the steel head.

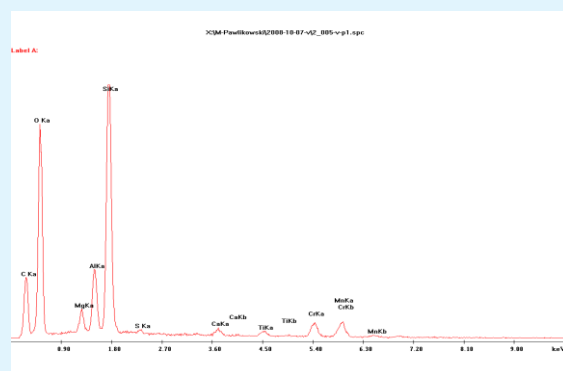
Figure 19: EDS energy spectrum of a silicate microslag torn out of steel from the head of endoprosthesis shown in Photo 16.

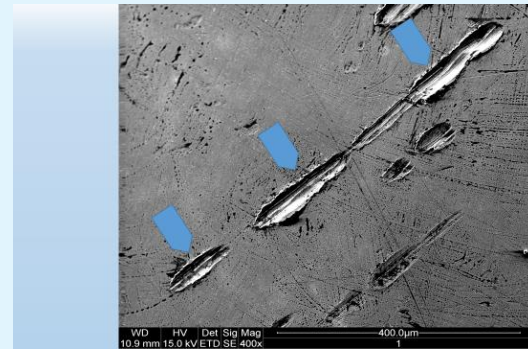
Figure 20: Damage to the surface of the steel head of endoprosthesis done by the micrograin of slag torn out of the steel. SEM.

Resulting cuts in the surface of the head (Figure 20) act like a sharp knife and damage the socket during movement, causing formation of small fragments. Those in turn may get into the circulatory system, promoting blockages of blood vessels, which may result in swelling of the joint area and gathering of fluid.

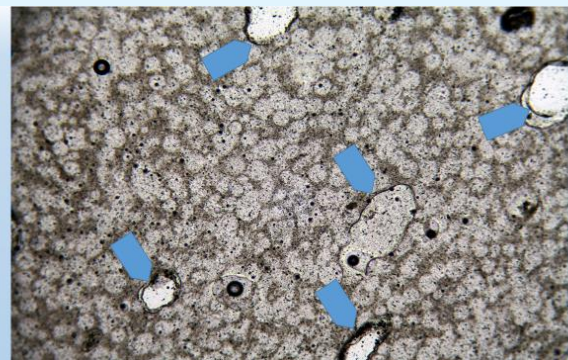
In the case of fast mixing of cement components, air gets into the mixture in the form of small bubbles, which may be sealed in the cement mass during its setting (Figure 21). The more bubbles in the cement, the weaker the binding of the endoprosthesis to the bone. The weaker the binding of the endoprosthesis to the bone, the greater the chance of its wavering during functioning.

Figure 21: Microscopic image of cement with air bubbles (arrows).

It appears beneficial to mix the components of cements binding the endoprosthesis in a container with pumped-out air.
