# Changing Climate and the Effect of Gully Erosion on Akpo Community Farmers in Anambra State, Nigeria

**Angela A\* and Ezeomede IC**

## Research article

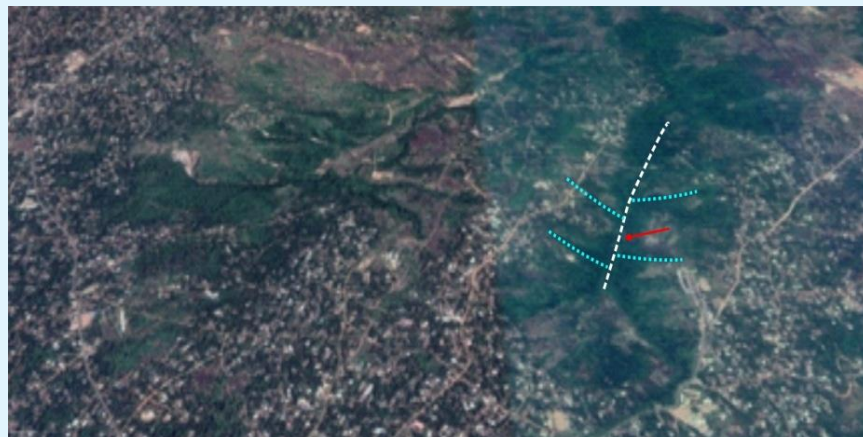
Further, figure 3 showed the main gully site in the satellite image of Akpo community indicating (See white dotted lines) several branches (See blue dotted lines). This revealed that the gully morphology is dendritic, spread with a network of branches as indicated in figure 3. Table 1 and figure 4 also indicated the gully erosion site characteristics and the Gully Site profile respectively. The gully channel is characterised by a V- shape (See plate 1) which is an indication that the surface soils are more erodible than the subsurface soils due to surface run-off producing concentrated overland flows that cut channels [39]. Figure 4 showed the cross section of the gully profile which is the intersection in a certain point along the gully longitudinal axis (X) of the resulting digital elevation model (DEM) with a plane perpendicular to the X-axis results in the cross section.

Figure 3: Satellite image of the study area.

Findings from the study also showed that gully erosion in Akpo community is dendritic and has a network of branches. Gully erosion characterization indicated a V-shape. This showed that surface soils are more erodible than the subsurface soils due to surface run-off producing concentrated overland flows that cut channels. Further, the length of the gully was 563m, the maximum elevation was 226m and the elevation gain was 0.9m representing the length of the horizontal projection of the straight line linking the upper end of both sides and the distances from the deepest points to the gully bed. The maximum slope was 2.2% which happens to be responsible for the distribution of the gullies on the spots along farmlands aiding the generation of sufficient volume of run-off.

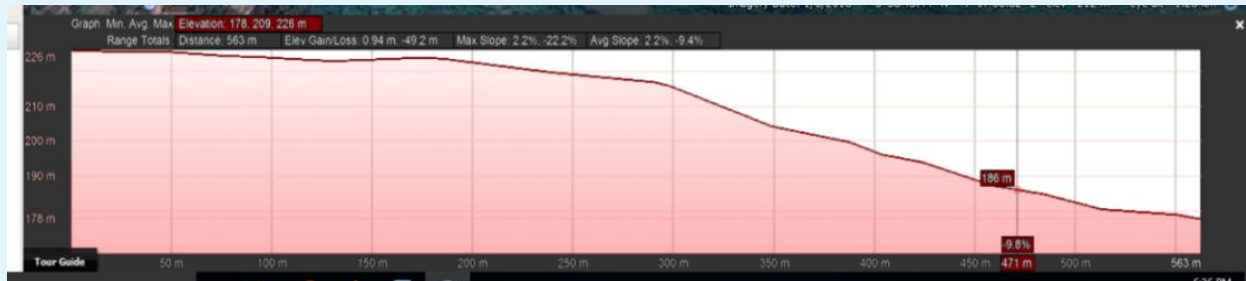
Results from this study showed that the gully length was 563m, the maximum elevation was 226m and the elevation gain was 0.9m representing the length of the horizontal projection of the straight line linking the upper end of both sides and the distances from the deepest points to the gully bed (A1-A2) as confirmed by Well et al. 2010 [40]. The maximum slope was 2.2% which happens to be responsible for the distribution of the gullies on the spots along farmlands aiding the generation of sufficient volume of run-off. Observations from the field also revealed that the V-shaped channels have high sand content as verified by Egboka, et al. 2016 [41], due to their low cohesion they are unable to support the high vertical sidewalls, and hence, there they can easily collapse.

Figure 4: Uhuala Gully Site profile  
Source: Author's Lab Analysis (2018).

Classes	Gully Length	Average Elevation	Maximum Elevation	Minimum Elevation	Elevation Gain	Elevation Loss	Minimum/Maximum slope
1	563m	209m	226m	178m	0.94m	-49.2m	2.2% to -22.2%

Table 1: Characterization of Uhuala Gully Erosion Site.  
Source: Result of Author's Lab Analysis, 2018.

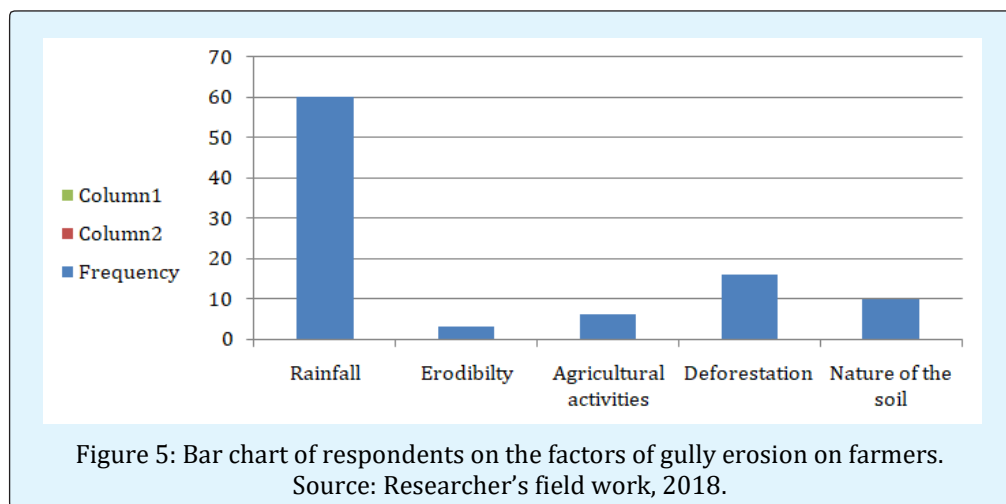
Table 2 showed the response of farmers towards the factors responsible for gully erosion in the study area; 63.2% of the farmers opined that rainfall is responsible for gully erosion, 3.16% farmers indicated erodibility, 6.32%

of the farmers choose agricultural activities, 16.8% and 10.0% respondents asserted it was deforestation and nature of the soils respectively. The table is presented in a bar chart (Figure 5).

Figure 5: Bar chart of respondents on the factors of gully erosion on farmers.  
Source: Researcher's field work, 2018.

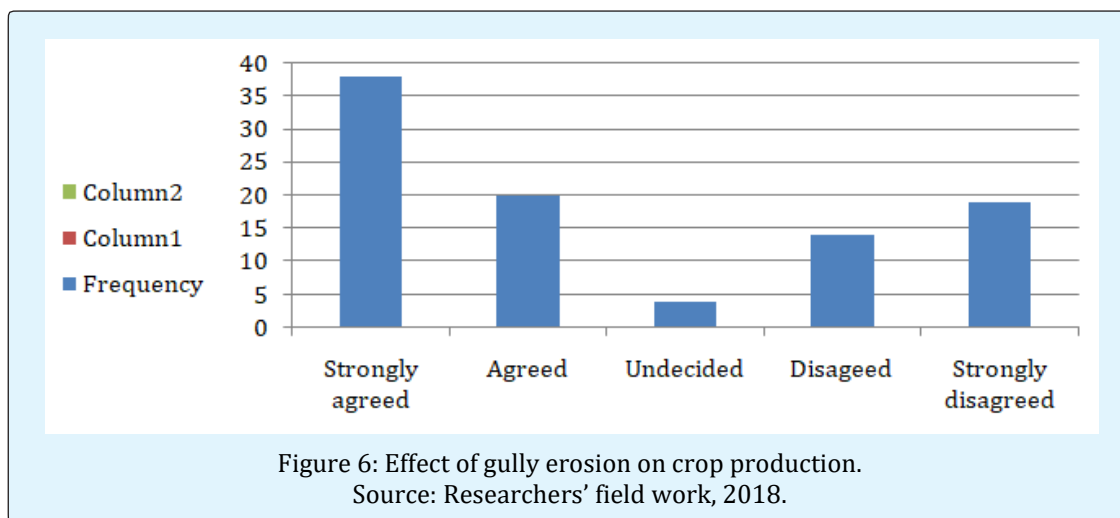
Table 3 indicated the frequency distribution of farmers on the influence of gully erosion on crop production. 40.0% of the farmers strongly agreed, 21.1% agreed, 20.0% strongly disagreed while 14.7% and 4.21%

were scored disagreed and undecided respectively. This implies that 58% of the farmers agreed that gully erosion affects crop production.

Figure 6: Effect of gully erosion on crop production.  
Source: Researchers' field work, 2018.

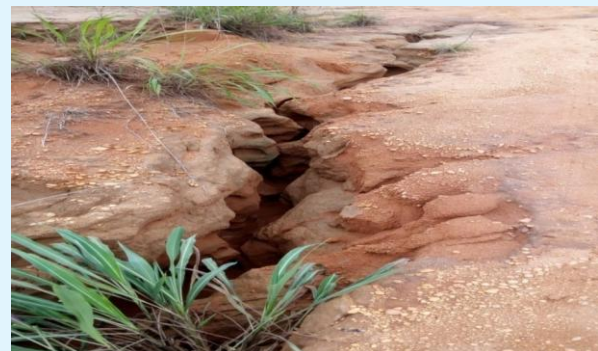
Plate 2: A young network of gully.  
Source: Researcher's field work (2018)

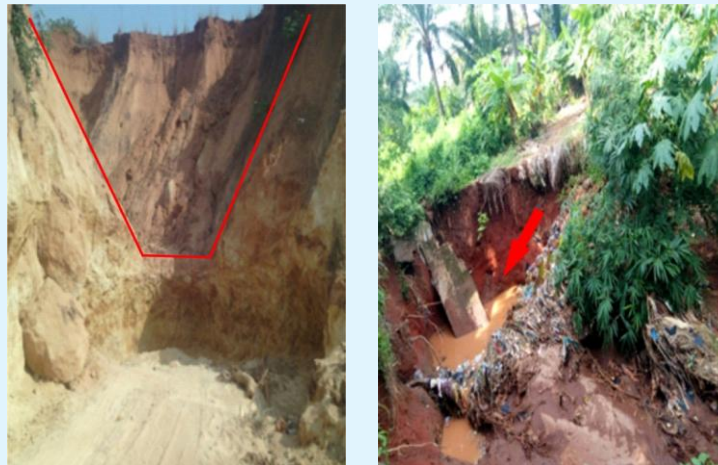
Plate 1: Showing V- shaped gully emanating along farming routes and Banana farms in the study area. Source: Researcher's field work (2018).

The implication of this is that croplands are being fragmented and lost as a result of the gully activities. Similar study carried out by Abdufatai, et al. confirmed the findings in this present work that vast areas of farmlands have been lost to gully erosion while others are at their various stages of destruction leading to drastic decrease in agricultural productivity and ultimately food shortage that can lead to famine if quick-sustainable actions are not applied [28].

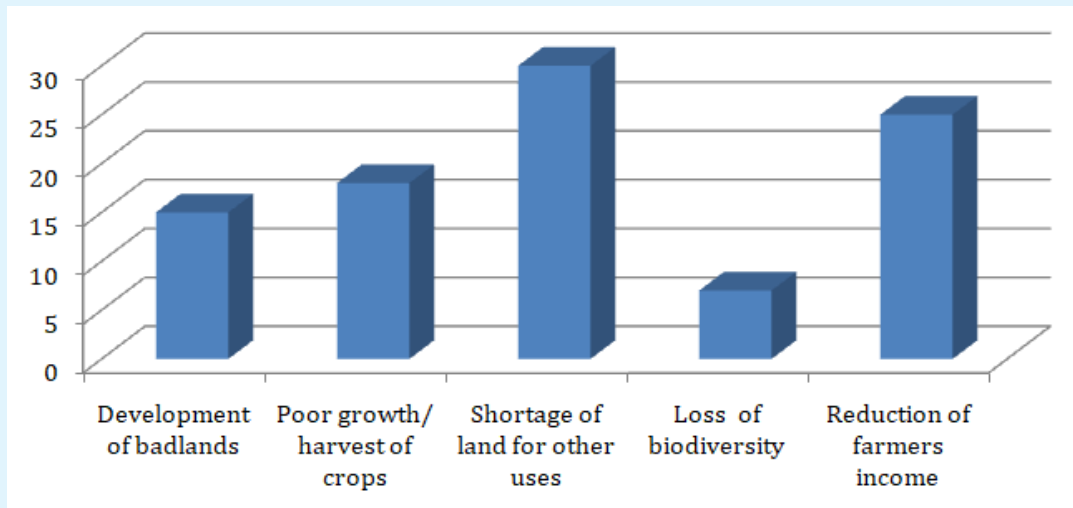
area was obtained. 1.05% had half a standard of land, 36.8% had 1-5 plots, 60.0% had 6-10 plots and 2.11% had above 10 plots. Obviously, majority of the lands were employed for farming purposes. Table 4 showed the response of farmers towards the socio-economic effect of gully erosion on Akpo community farmers. 15.8% and 18.9% of the farmers opined that development of Bad Lands and poor growth/ harvest of crops had negative effect on farming, 31.6% and 7.4% farmers were of the opinion that shortage of land for other uses and loss of biodiversity had negative effect too, while 26.3% of the respondents stated reduction of farmers income. The table is presented in a bar chart (Figure 7).

Figure 7: Bar chart of respondents on the impact of gully erosion on Akpo community farmers.
