# A Simplified Technique for Retrofitting a Post and Core Foundation to a Pre-existing Crown: A Case Report

## Case Report

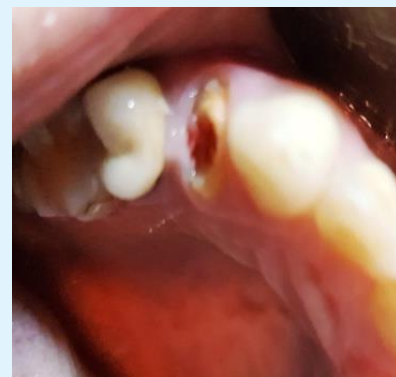
A 40-year healthy female presented to Aseer specialist dental center in emergency with a loss of esthetic crown related to the maxillary premolar (Figure 1).

Figure 1: Initial case.

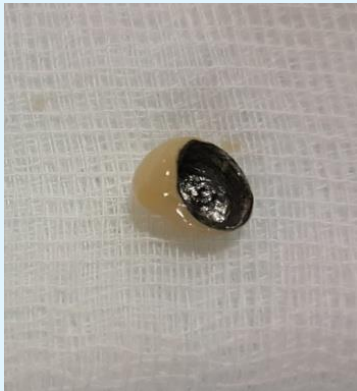
Figure 2: Pre-existence metal ceramic crown.

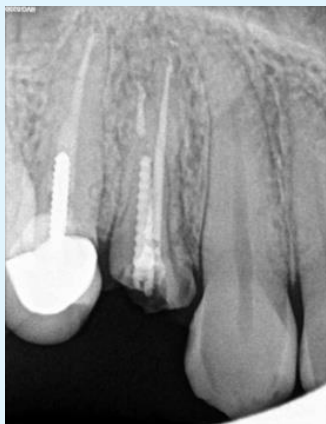
The patient sought for a quick and urgent aesthetic and functional solution. On examination, Patient had no medical history. Dental history did not reveal any past present symptom. A metal ceramic crown overlying the maxillary right first premolar as extracoronal full coverage prosthesis was seen dislodged since two weeks and remaining intact, whereas elsewhere a gingival hypertrophy has developed in the distal face of this tooth. The maxillary right first Premolar was decayed with sound dentine height of less than 1mm (arrow) between the remaining already prepared tooth and crown margins (Figure 2). It was endodontically treated and with a remaining screw post in the post space of the buccal canal (Figure 3).

Figure 3: Maxillary right first Premolar was endodontically treated tooth, with a remaining screw post.

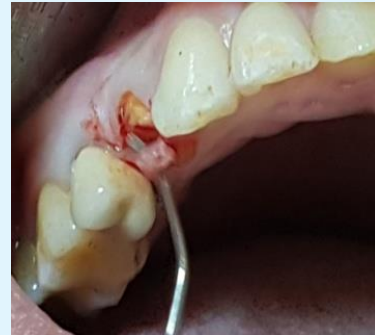
Figure 4: Surgical crown lengthening.

Moreover the patient has undergone a gingivectomy (Figure 4) to ensure a distal crown lengthening. In order to exhibit the finish line that can be used to maintain periodontal health and long-term stability of the restorations.

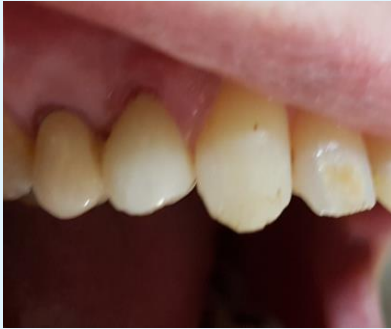
Figure 5: Using the existing prosthesis as a provisional.

The interim restoration was performed by two techniques: by Using the existing prosthesis as a provisional restoration which was lined with autopolymerising resin (Figure 5) or a preformed polycarbonate crown which needed addition by the lining procedure and some modification (internal relief, axial recontouring, occlusal adjustment) (Figure 6) and each technique needed a metal post to improve retention which was inserted in the remaining post space already under taken for the old screw post. Thus the interim crown was a temporary post crown (Figure 7) which provides occlusal function, protection of the tooth structure, ability to be cleaned, and restores function and

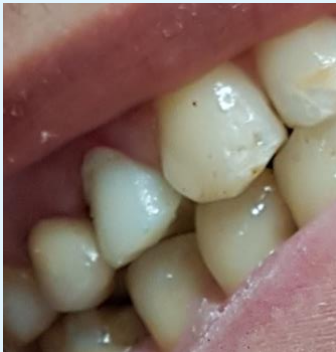
Figure 6: A preformed restoration polycarbonate crown as Interim crown.

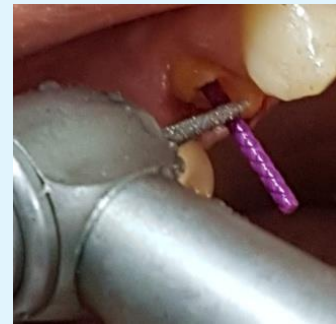
Figure 8: The plastic post was adjusted by cutting.

After three weeks the healing of the gum related to the gingiva was well improved. Once selecting an appropriate size of plastic post (Para-Post, Whale dent International, New York, N.Y.), it was inserted into the prepared root canal. The length of the post was adjusted by cutting with a bur (Figure 8) so it did not interfere with the inner surface of the crown which may compromise accurate seating and appropriate occlusion.

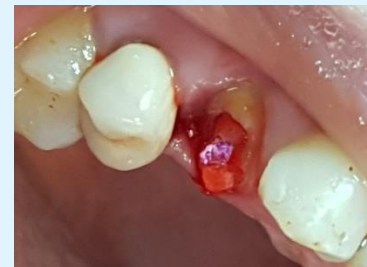
Figure 9: The plastic post was rebased with duralay resin.

After applying a layer of lubricant to the tooth structure an autopolymerizing acrylic resin material (Duralay, Reliance Dental Mfg Co, Alsip, Ill.) was used to rebase the plastic post and to coat its coronal part to ensure better adaptation to the tooth flared canal and pulp chamber structure (Figure 9).

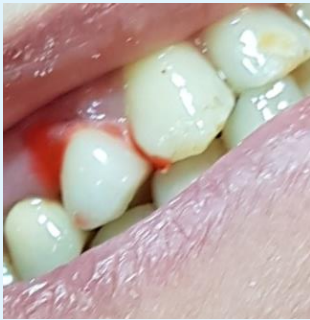
Figure 10: Post and core pattern performed.

The inner surface of the crown was lubricated with petroleum jelly, which allowed for easy removal of the direct pattern made by resin duralay build up for the direct casted post and core. After mixing, the duralay resin material was filled into the inner aspect, then the patient was asked to close in the position of maximum intercuspation (MI) (Figure10) until the resin material completely polymerizes to avoid over-occlusion. Once the post and core pattern removed from the abutment tooth (sometimes from the existing crown), it was checked and any projection of material may remain over the margin was eliminated (Figures 10-12). It was also refined and sent to the lab for investing and casting (Figure13).

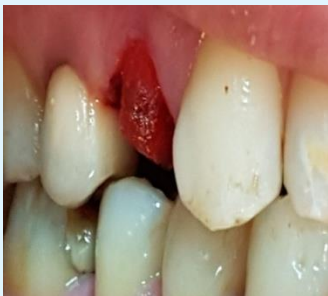
Figure 11: Post and core pattern in maximum intercuspation.

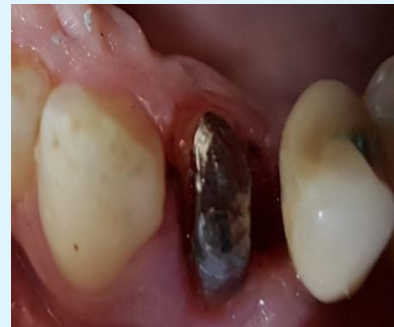
Figure 14: Try in casted post and core without.

The casted post and cores was tried in the mouth without the crown (Figure 14) to ensure the perfect adaptation, then in a second time with the crown in situ to confirm fit, insertion, retention, marginal integrity, and to verify the occlusion during static and functional movements (Figure 15). Adequate cement thickness was ensured by the finishing procedures of the casted post and core that respected the existing tooth margins.

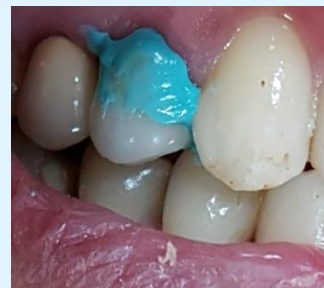
Figure 15: Checking occlusion crown.

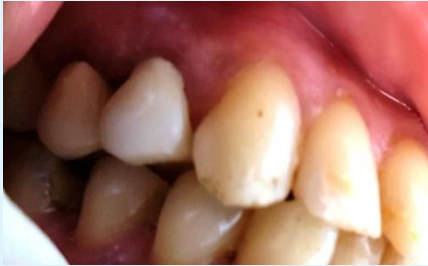
Figure 16: Cementation of the pre-existing crown.

In the clinic the casted post and cores and the existing old metal ceramic crown were cemented simultaneously using adhesive cement (Figure 16).
