A Simplified Technique for Repair an Abutment Tooth under Preexisting Crown: A Case Report

Case Report

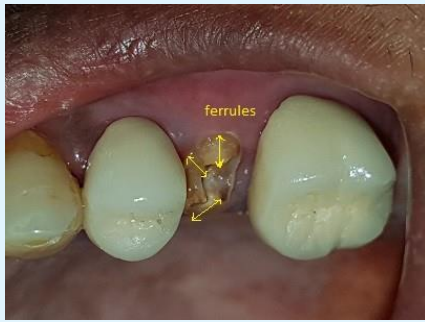
Figure 1: Initial case crown.

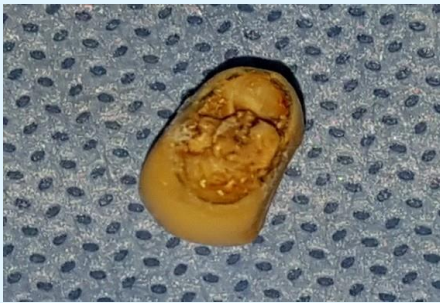
A 48-year-old healthy female presented to Prince Sultan specialist dental center in emergency with a dislodged metal ceramic crown overlaying a fractured core (Figure 1) on the maxillary left second premolar in an esthetic zone (Figure 2).

Figure 2: Pre-existing metal ceramic crown with fractured abutment.

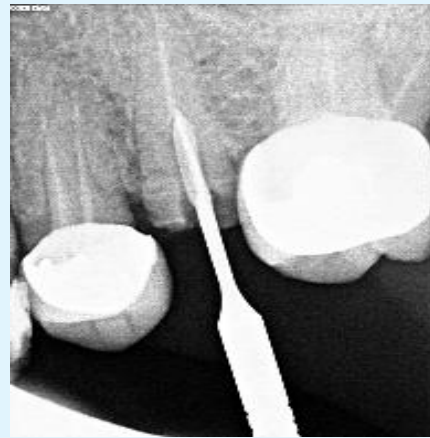
Figure 4: Removing of remaining fiber post.

The patient was given the option of retrograde fiber post-supported core build up and recementation the same metal ceramic crown, or fabrication of a new crown. Because of the costs and duration involved in the fabrication of a new metal ceramic crown the patient chose the same crown recemented. All the remnants of the old composite left on the fractured abutment were removed by using an ultrasonic scaler and the remaining fiber post was removed by using the combination diamond plus Largo burs (Figure 4) [12]. Nevertheless utmost care should be taken during removing to avoid a root perforation. On another hand the remaining fractured abutment was also removed from the inner surface of the metal ceramic crown (Figure 5).

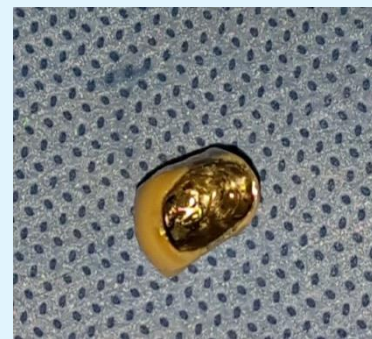
Figure 5: removing of fractured abutment from the intaglio surface of the crown.

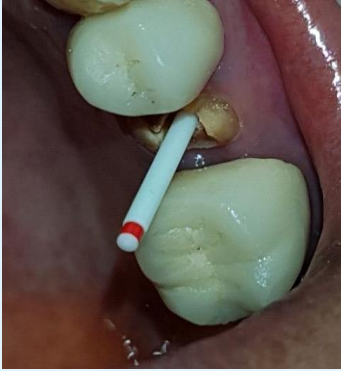
Figure 6: A prefabricated light post was adhesively cemented.

After Preparation of the post space, the tooth was cleaned with water and air dry, then an etchant (Total etch, Ivoclar Vivadent, Schaan, Liechtenstein) was applied to the remaining tooth surfaces and post space for 15 seconds, rinsed, and air dried. Two coats of the bonding material (Prime and Bond NT, Dentsply) were applied to

the tooth surface coronally to the finish line and light-polymerize for 20 seconds and then applied again in the post space. A prefabricated light post (D. T. Light-Posts; Bisco Inc. Illinois, USA) of appropriate size was adhesively cemented using dual-cure resin cement (Duolink, BiscoInc, Schaumburg, USA) (Figure 6) [9].

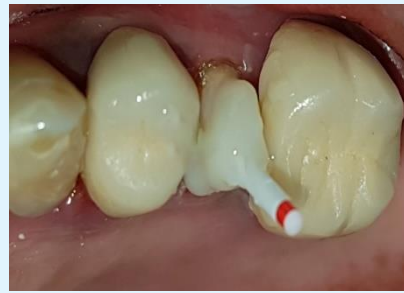
Figure 7: Composite core build up.

Small amounts of dual-polymerizing core foundation composite (Bis-Core; Bisco Inc. Schaumburg, Illinois, USA) were used to build up layer by layer the core (Figure 7).

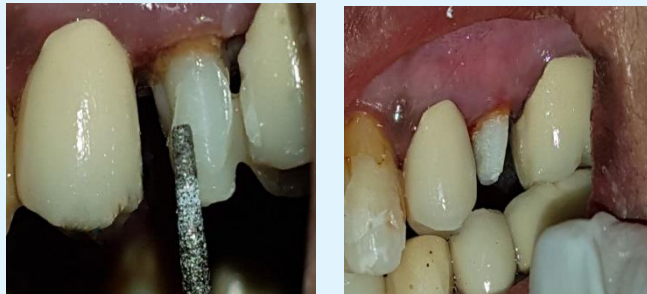
Figures 8 & 9: Removing of the excess of composite core.

The post length was adjusted coronally and the new abutment was trimmed in an empirical way (Figures 8 & 9) till the ceramo metal crown seated completely with accurate margin fitting and with the same static and dynamic occlusal as before abutment fracture.

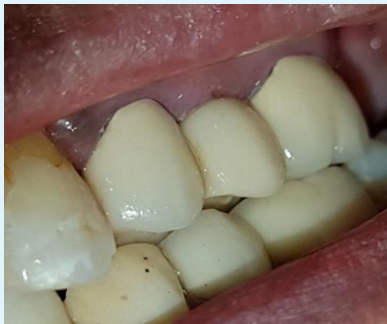
Figure 10: Accurate margin fitting and with the same occlusal as before abutment fracture.

The glass-fiber posts and composite buildup allowed adequate stability and retention to the original crown figure when placed onto the remaining core to verify the marginal adaptation (Figure 10).

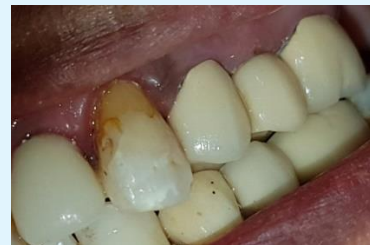
Figure 11: The intaglio surface filled with dual-polymerizing core foundation composite in the position of maximum intercuspation (MI).

The intaglio surface was lubricated with petroleum jelly, which allowed for easy removal of the crown and then filled with dual-polymerizing core foundation composite (Bis-Core; Bisco Inc. Schaumburg, Illinois, USA), then the patient was asked to close in the position of maximum intercuspation (MI) (Figure 11).

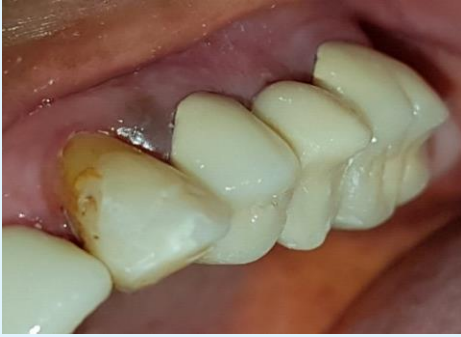
Figure 12: Pre-existing metal ceramic crown cemented using luting cement.

After an initial polymerisation with a light-polymerizing unit (QHL 75 Curing light, Dentsply) for 5 seconds and the excess composite material was gently removed from the margin with a probe. After removing the crowns, the core foundation composite was light-polymerized for 40 seconds the core surface was finished with a fine finishing bur with a fine grit diamond point. After sandblasting the inner surface of the crown in the lab, it was cemented in the clinic with using luting cement (RelyX Capsule, 3M, St. Paul, MN, USA) (Figure 12).
