# Esthetic Replacement of Composite Veneers by Lithium Disilicate (E.Max CAD) Based Crowns: A Case Report

## Case Report

This case report highlights the rehabilitation of aesthetic smile by Lithium Disilicate (IPS e.max CAD) ceramic crowns of all upper anterior teeth that were compromised due to previous defective old composite veneers with poor color and design in esthetic zone.

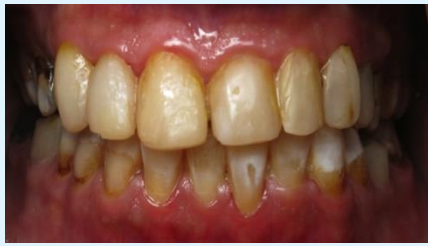
A 44-year-old female patient was referred to the clinical concerned about her smile, her chief complaint was that (I don't like the appearance of my front teeth) she was not happy with her previous treatment (Figure 1).

**Figure 1:** Initial case frontal view.

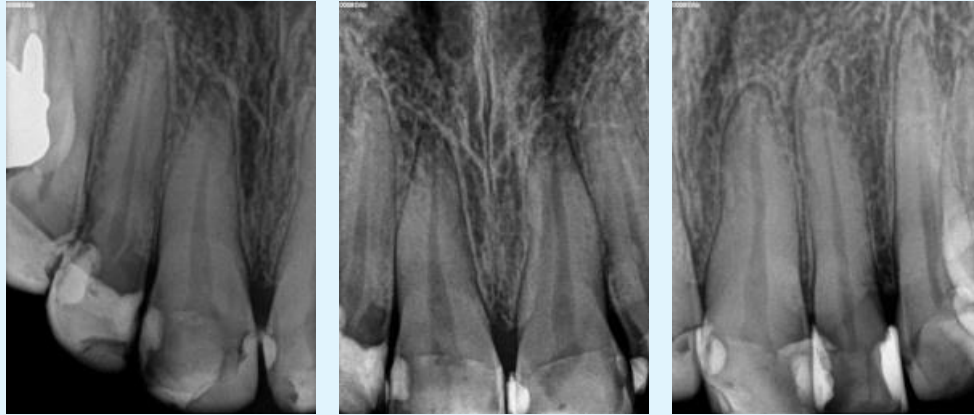
The clinical examination and history revealed that the patient was within normal ranges. Clinical and radiographic examinations showed (Figure 2) old composite veneer restorations of all upper anterior teeth, secondary caries were detected at the mesial and distal surfaces of maxillary central lateral incisors and canines of the patient (Figure 2). There was also a discrepancy in the width and length of the central Incisors, poor adaptation and polishing of composite (Figure 3).

**Figure 2:** Preoperative periapical x-ray.

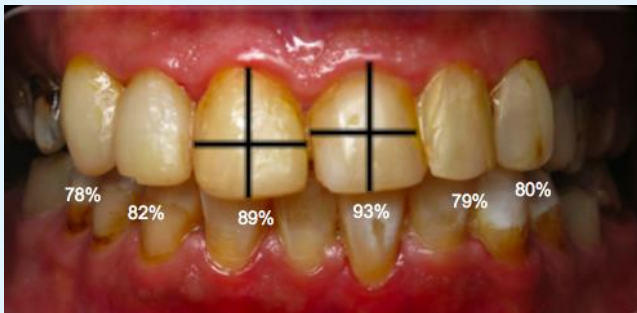
**Figure 3:** Initial case showing discrepancy in the width and length of the central Incisors.

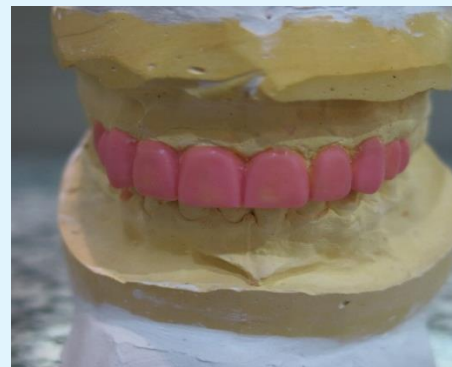
**Figure 4:** Mounted diagnostic wax-up on articulator for final diagnostic appearance.

incisors and canines was planned, thanks to their more tooth-like appearance and sufficient strength. During the first appointment a silicone primary impression was taken for the preliminary wax-up. The models were mounted on a semi adjustable articulator (Figure 4).

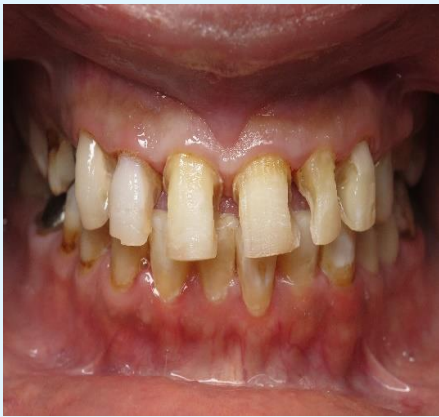
**Figure 4:** Initial preparation and caries removal.

The treatment protocol should be as conservative as possible with less reduction of teeth structure and greater esthetics and longevity [15]. The shade of maxillary teeth was selected as 1M1 using Vita 3D master. The preparations were performed respecting the shared preparation principles in the anterior regions for all systems (i.e., single-unit and FPD abutment) include an incisal reduction of 1.5mm to 2mm with diamond burs for incisors canines and finish line for each tooth was a deep chamfer [16]. During preparation of anterior teeth the carious lesions were removed (Figure 4) and direct composite restorations were performed (Figure 5). There was a large amount of lost tooth structure due to secondary caries and great care should be taken during caries excavation to avoid pulp exposure, which will need a root canal treatment and may change the treatment procedure.

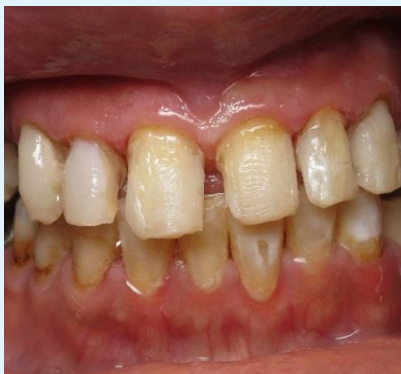
**Figure 5:** Restorations by composite.

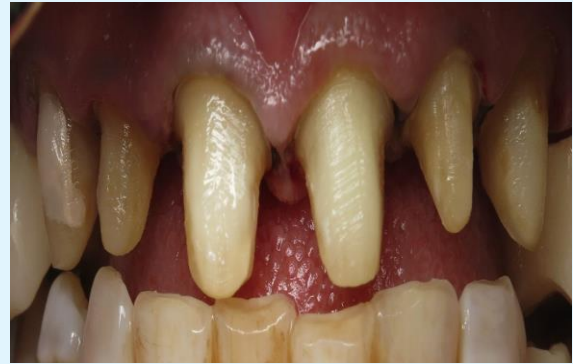
**Figure 6:** Final preparations; buccal view.

Provisional restorations were made by an index using bis-acryl resin (Protemp). Most CAD/CAM systems recommend that the minimum axial wall reduction for anterior crowns should be 1 mm to 1.5 mm. The total

occlusal convergence angle can range between 4° to 6° (Figure 6). Finishing and polishing of preparation of the teeth were performed with diamond points using a speed multiplier (W & H Dentalwerk, Bürmoos, Austria).

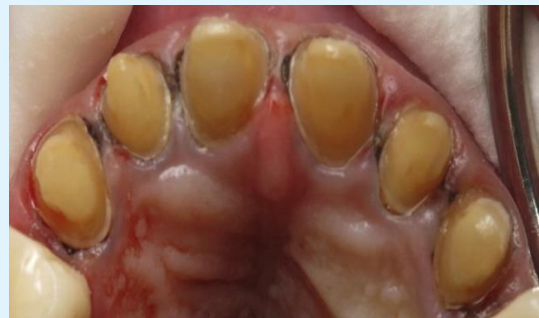
**Figure 7:** Final preparations occlusal view.

On another hand Provisional restorations were made by an index using bis-acryl resin (Protemp) (Figures 7,8) and cemented with temporary free eugenol cement. They were used as prototype to assess esthetic, phonation and occlusal scheme of patient they were also well accepted by the patient.

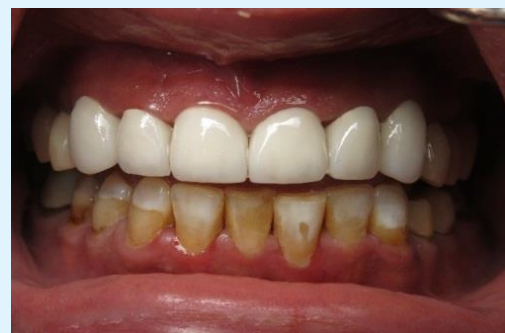
**Figure 8:** Interim crowns.

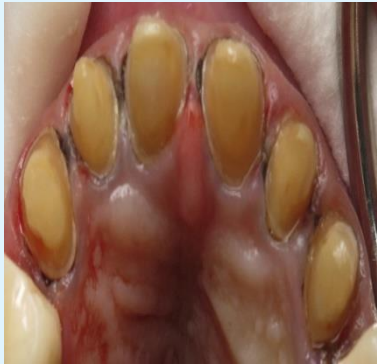
**Figure 9:** Gingival retraction using impression.

After gingival retraction carried out using an impregnated cord (Figure 9) a final impression was taken using polyvinyl siloxane (Virtual, Ivoclar Vivadent) (Figure 10) and sent to the laboratory.

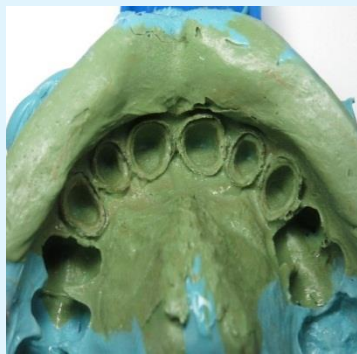
**Figure 10:** Final impregnated cords.

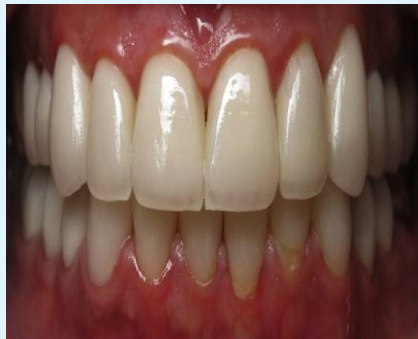
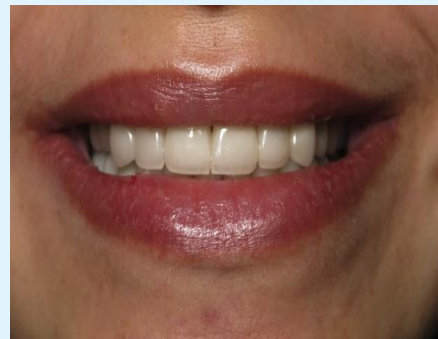
**Figures 11 & 12:** Extra-oral view after final cementation.

Beforehand correct path of insertion of the 6 crowns should be clearly determined to allow an accurate crown seating in the arch during cementation. In the clinic, after ceramic stratification in the lab, esthetic and static and functional occlusion were checked, and crowns were sent again to the lab for glazing. The abutments were cleaned to remove the temporary cement which can jeopardize not only the precision of seating, but also the optimal bonding of the glaze ceramic crowns. The inner surfaces of the disilicate crowns were etched with 10% of hydrofluoric acid for 1.5 minutes and dried, then a coat of silane coupling agent was applied for 1 minute [17]. The cementation was carried out with a dual cure luting agent Rely X U 200(3M ESPE) using the quarter technique (Figures 11 & 12).
