Right Bundle Branch Block in Right Ventricular Apical Pacing

Case Report

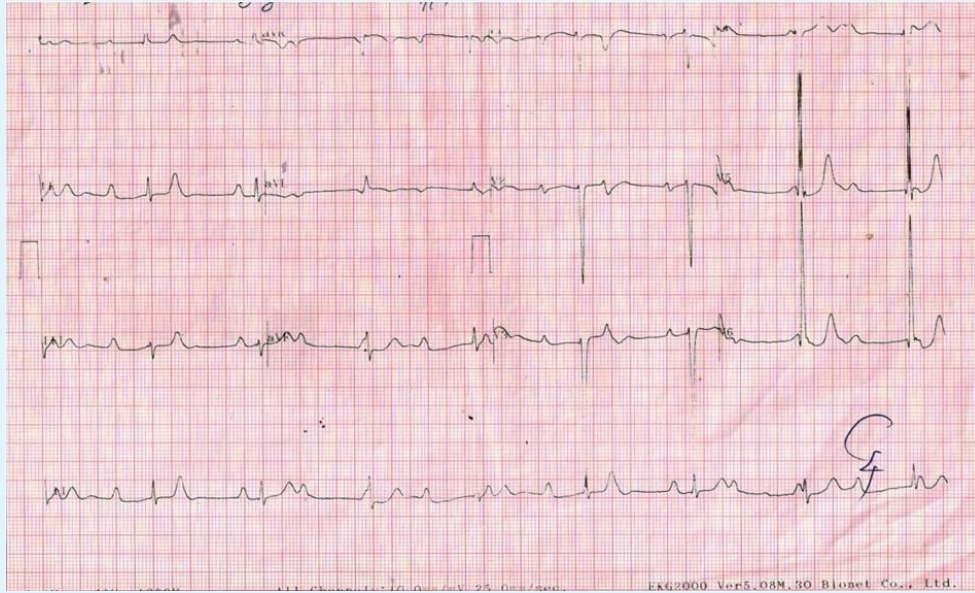
Figure 1: ECG on admission showed third degree AV block with suprahisian escape rhythm.

ECG done prior to cataract surgery 1 year ago was normal. General examination was normal. Pulse rate was 46/min, regular & felt in all peripheral pulses. Blood Pressure was 130/70 mmHg in both upper limbs. JVP showed intermittent cannon 'a' wave. Systemic examination was normal. ECG showed atrioventricular (AV) dissociation with atrial rate of 100 bpm & ventricular rate of 48 bpm suggestive of III° AV Block with suprahisian escape rhythm (Figure 1). Echocardiography showed no wall motion abnormality with normal ejection fraction. Holter monitoring showed complete heart block throughout with average heart rate of 54 bpm, minimum heart rate of 38 bpm and longest R- R interval was 2.7 seconds. Baseline investigations including thyroid function tests were normal. Permanent pacemaker implantation (MEDTRONIC RELIA) with VVI mode was done via left subclavian approach under local anaesthesia. Bipolar endocardial tined pacing lead was positioned in RV apex which was confirmed by fluoroscopy in both AP & lateral

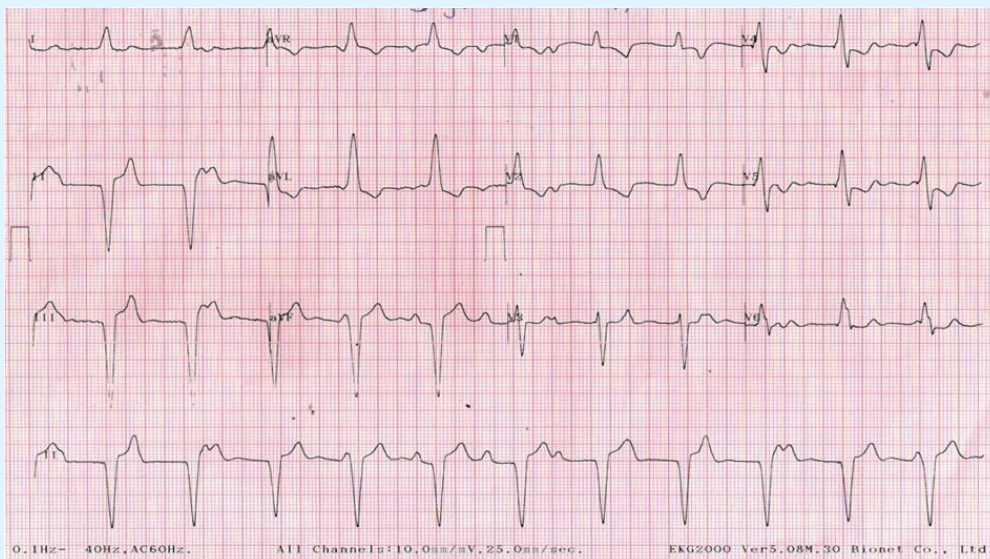
Figure 2: ECG following pacemaker implantation showed QRS axis of around -60° and RBBB pattern in leads V1 & V2 with precordial transition in lead V3.

views (Figure 4). Procedure was uneventful. Post procedure ECG showed pacing rhythm with RBBB morphology in leads V1 & V2 with frontal QRS axis of around -60° (Figure 2). Echocardiography revealed pacing lead in RV apex (Figure 5). Notwithstanding, serial ECGs taken showed pacing rhythm with RBBB pacing morphology in V1 & V2 leads. ECG done with leads V1 &

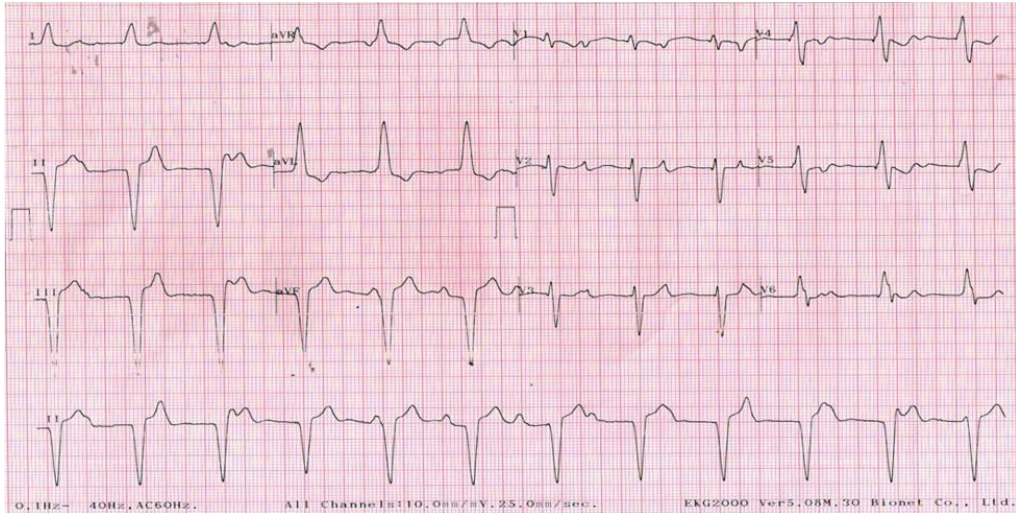
Figure 3: ECG taken with leads V1 & V2 placed 1 inter costal space lower than standard position showed disappearance of RBBB morphology in V1 & v2 leads.

V2 placed one inter costal space below the standard position showed disappearance of RBBB pattern in V1 & V2 (Figure 3). Chest X rays both PA & lateral views confirmed the lead position in RV apex (Figure 6). Hence, patient was reassured and discharged in stable condition. During follow up patient was found to be asymptomatic and clinically stable. We report this case for its rarity.

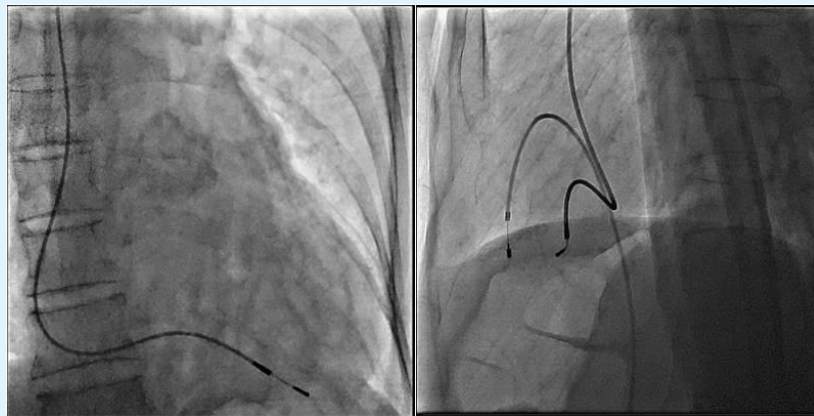
Figure 4: Fluoroscopy (AP & Lateral views) confirmed the pacing lead in right ventricle apex.

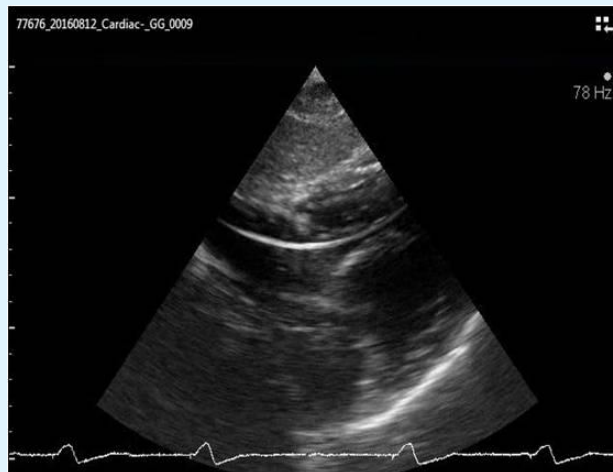
Figure 5: Echocardiogram (Sub costal view) showing pacing lead in RV apex.

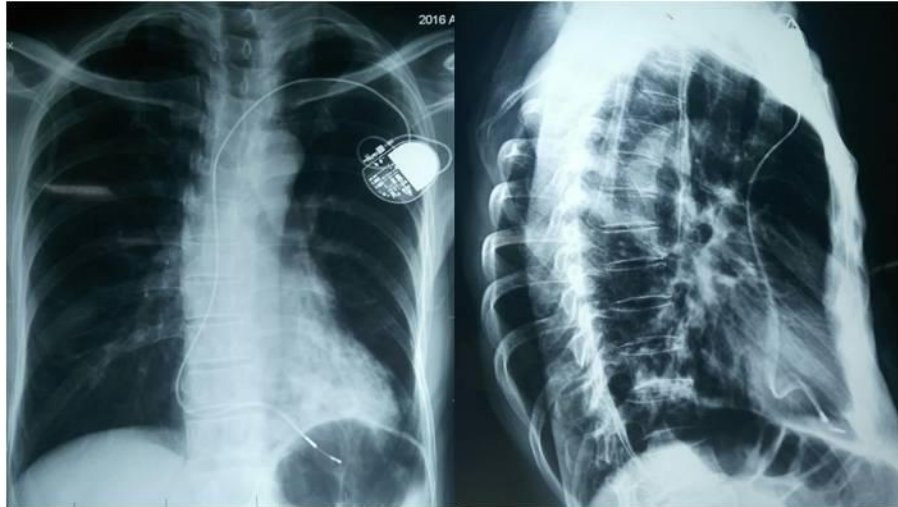
Figure 6: Chest X Ray (PA & Lateral views) showed pacing lead in RV apex.
